# Secondary Belt Feeders

#### Feeding -14" Shot Rock at 800 TPH.

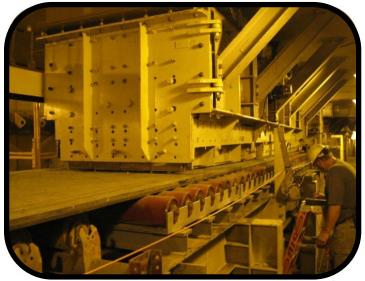
These feeders were fitted with an internal Loading Shoe and a Roller Table.

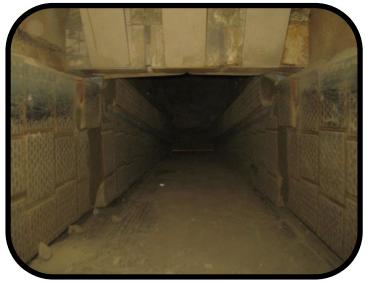
Internal Loading Shoe is fitted with ceramic liners on the Feeder Walls. Strike-off bar is overhead.

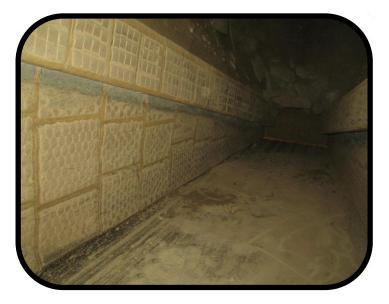
Looking toward the tail of the Loading Shoe. Top left is the engineered ceramic Deadbed Bar that protects the tapered floor of the Shoe.

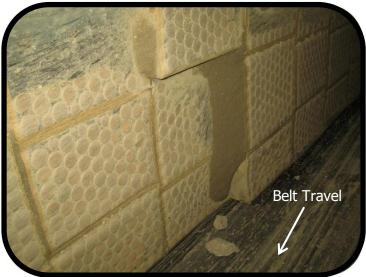
Special geometry is used effectively to relieve the side pressures on the liner package. The liners on the right hand side are inside the Shoe.

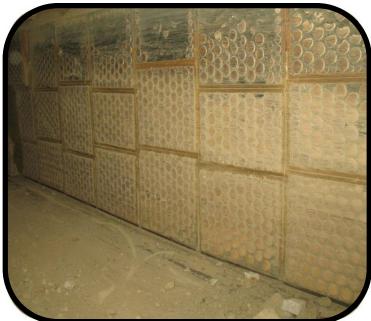
## **Discharge Zone**

The discharge zone liners are in excellent condition. These now have an operating lifecycle of 3-5 years. Previously, 2" Hardox 600 liners had a 90 day lifecycle.

The ceramic/rubber liners in this area are held inplace with two 1" mounting bolts, attached from the outside of the feeder. This provides a smooth face for uninterrupted material flow out the feeder. Liner weights are held to manageable limits for removing by hand.

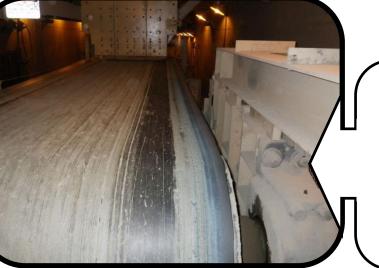
Belt life is drastically improved from 90 days to now over three years ...and still going. (This belt was not replaced during the installation of the new upgrade.) Notice the polished smooth top cover that tracks under the new ceramic liners in the Loading Shoe. After three years, it is still unknown how long these belts may ultimately last.

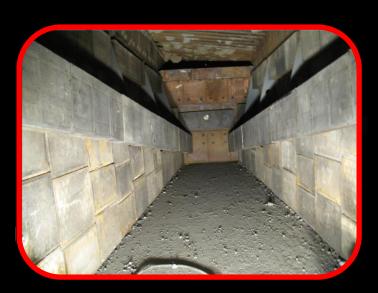
**Completion of Installation**

**(Right)** All of the components are modeled in 3D eliminating interference fit issues during installation. Loading Shoe Platform is fabricated 1" plate.

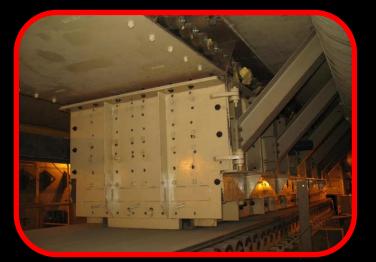
**Converted Feeder viewed from the back**

(Left) The liners on the back wall were left as steel on this retrofit. Notice the rubber skin is covering the ceramic embedded liners in both the Deadbed Bars and the Loading Shoe Wall Liners. These liners are custom designed for this feeder application with specific internal steel gusseting, attachment hardware points and retaining steel for the ceramic. Overhead, 2" diameter spile bars.
