Primary Belt Feeders

Our Primary Belt Feeders can replace your apron/pan feeders

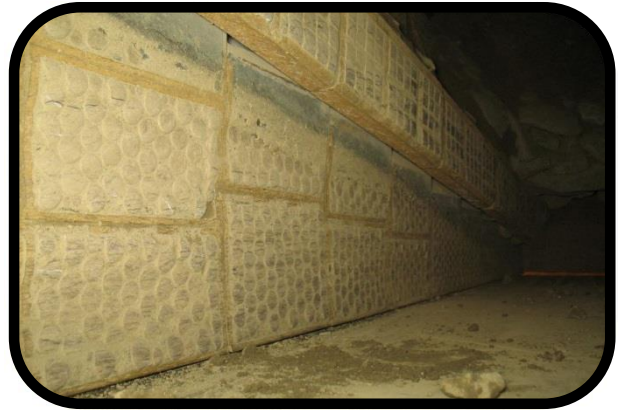
Existing loading shoe in a 60" Feeder taken at 50 weeks

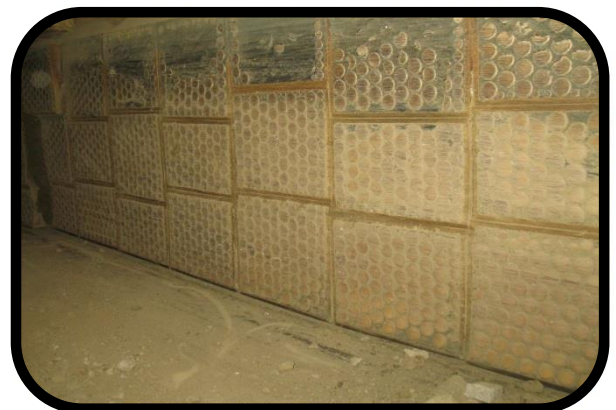
Discharge wall in a 60" feeder

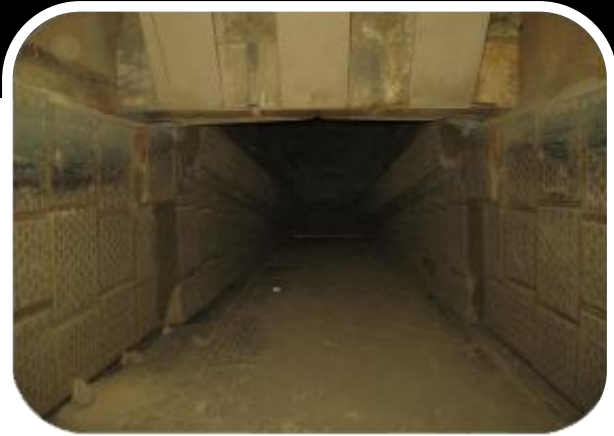
(Below) Top view of the double-tapered Loading Shoe. This is a significant reason for the reduction in shear forces in the drawdown and transition zone within the feeder.

One of the key features of the Feeder System is the modulating of forces within the feeder drawdown compartment into the loading shoe. Specific to this is the proper placement and geometric design of the liners in the flow-zone surrounding the strikeoff bar. This is critical if liner performance and belt life are to be maximized. The optimum configuration allows for material to move with the belt and not be pulled and/or sheared by the belt.

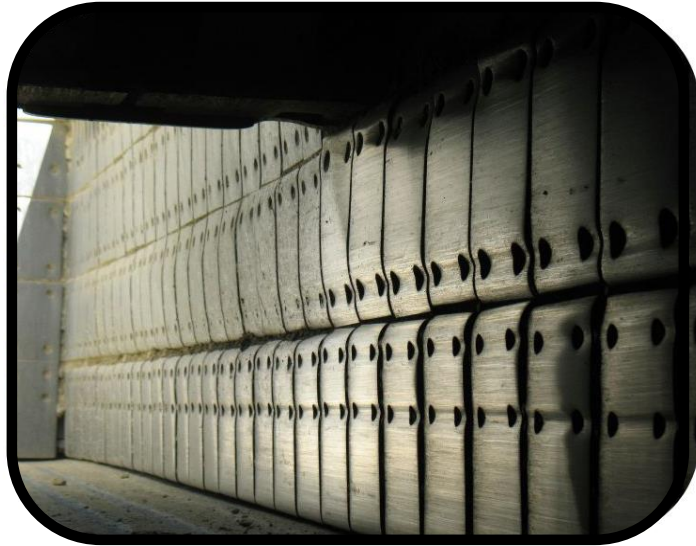
AR600 Steel (2" thick)

Lifecycle; approximately 90 Days

Cost/ft² ~ = \$450.00

Cost/week = $\$450.00/14 = \$32.00/\text{week}$

In the location pictured, the custom designed Rubber/Ceramic liners are over 7 times more cost effective than the previous steel liners. This does not take into account labor or hardware replacements for the steel liners, such as countersink bolts.

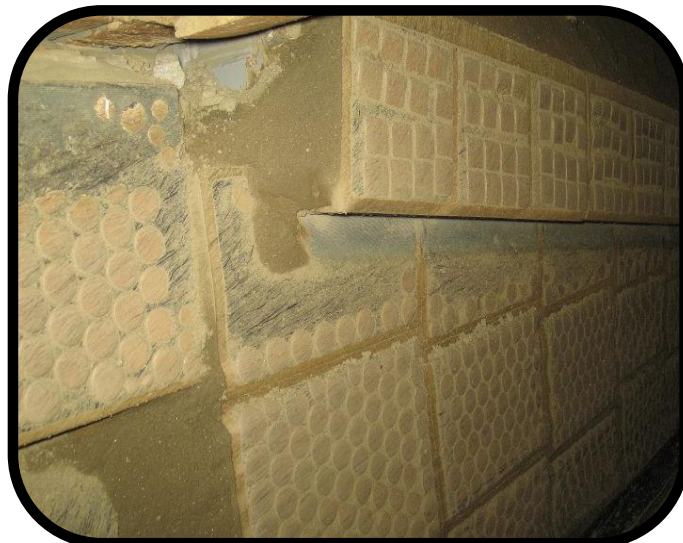
Rubber and Ceramic (2" thick)

Pictured Above; 114 Weeks and still running...

Cost/ft² ~ = \$482.00

Cost/week = $\$482.00/114 = \$4.22/\text{week}$
