## Reduced Maintenance Costs, Increased Production

Prior to using Valley Rubber BeltSeal-Kits, operations have experienced the following issues: **excessive maintenance, MSHA and EPA violations, followed with the inability to meet full production.** Below are four illustrations demonstrating how BeltSeal-Kits and their components have provided solutions to common plant issues.

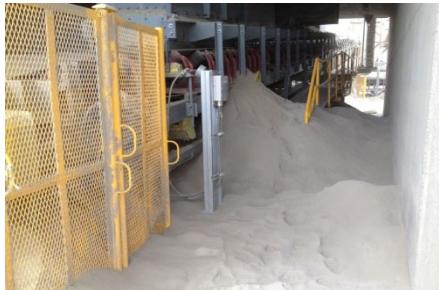
An operation's load zone was not properly supported which allowed the belt to porpoise between the impact idlers. Significant spillage, dust and maintenance resulted from this issue. The Load Zone was running 3000TPH with two Cone Crushers at 1,100hp each, crushing 14" minus material to  $\frac{3}{4}$ " minus. A three-man crew spent six hours twice a week cleaning up the spillage.

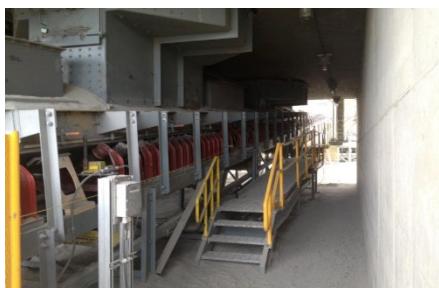
**Solution:** Valley Rubber's solution included adding BeltSeal Clamps with DoubleLip DustSeal skirting and Impact Idlers that are spaced tighter together. Adjustable BeltStabilizer Brackets and Bars were installed between the troughing idlers. A BeltSeal-Kit and TailSeal-Kit were installed, and the three-man cleanup crew now only had to come once every two weeks.

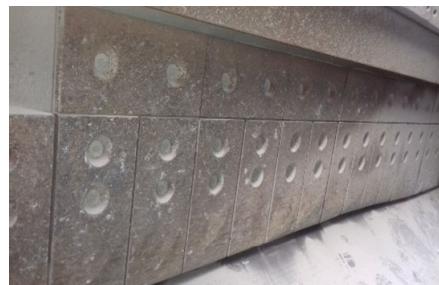
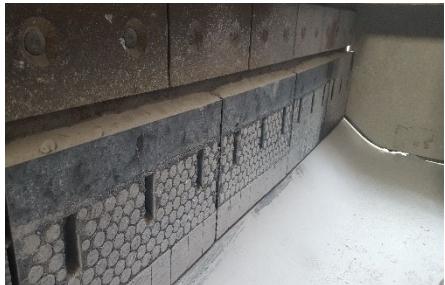
Steel liners in a Latin American operation were only lasting 45 days. There was an increased cost-per-ton, along with spillage, dust and noise.

**Solution:** Rubber Ceramic liners were installed and after fifteen months are still in operation. Canoe Liners simplify installation, adjustment and alignment. They are anchored to the canoe frame using T-Bolts that are embedded within the Canoe Liner.

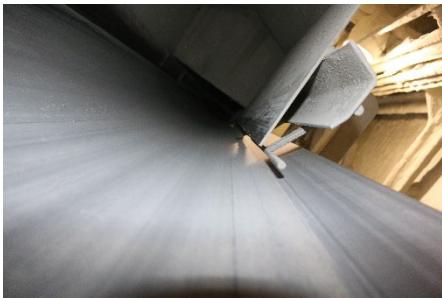
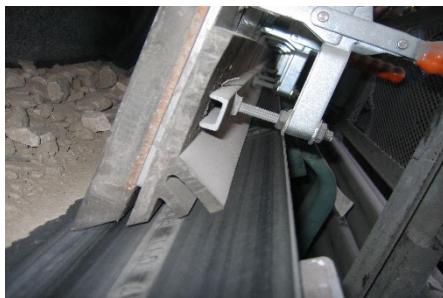
Typical seals are sold in large rolls that are hard to handle and ineffective.

**Solution:** DustSeals are effective and easy to handle and are supplied in 10' lengths. Valley Rubber offers DoubleLip and TripleLip-DustSeals that are designed to work in conjunction with our BeltSeal components.

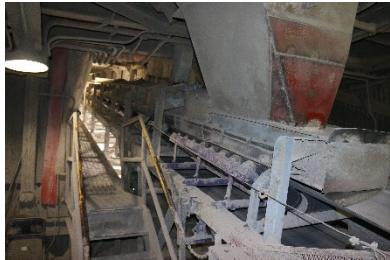
It is common to see either a piece of conveyor belt bolted to the rear of the canoe, or a slab of rubber bolted in the same fashion. Unable to be adjusted, these quick fixes are time consuming and rarely maintained, causing continued spillage and dust issues. The previous system pictured resulted in costly fines, excessive maintenance, loss of production and structural weight load concerns due to spillage.

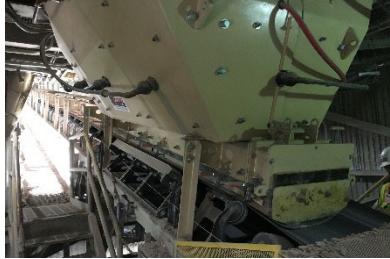
**Solution:** The TailSeal-Kit utilizes a system that incorporates three molded rubber blades that are adjustable using stainless steel t-handled screws. This allows for three points of contact to create a seal on the belt. Then for ease of inspection and maintenance, the system is hinged for access.
