Peru Canoe Liners

A new concentrator plant was built in a Peruvian mine where an important technological improvement was introduced to aid in feeding the two concentrators. Currently 74,800 tons-per-day are conveyor-fed to the Intermediate Dome, with a projected increase to 160,000 tons-per-day.

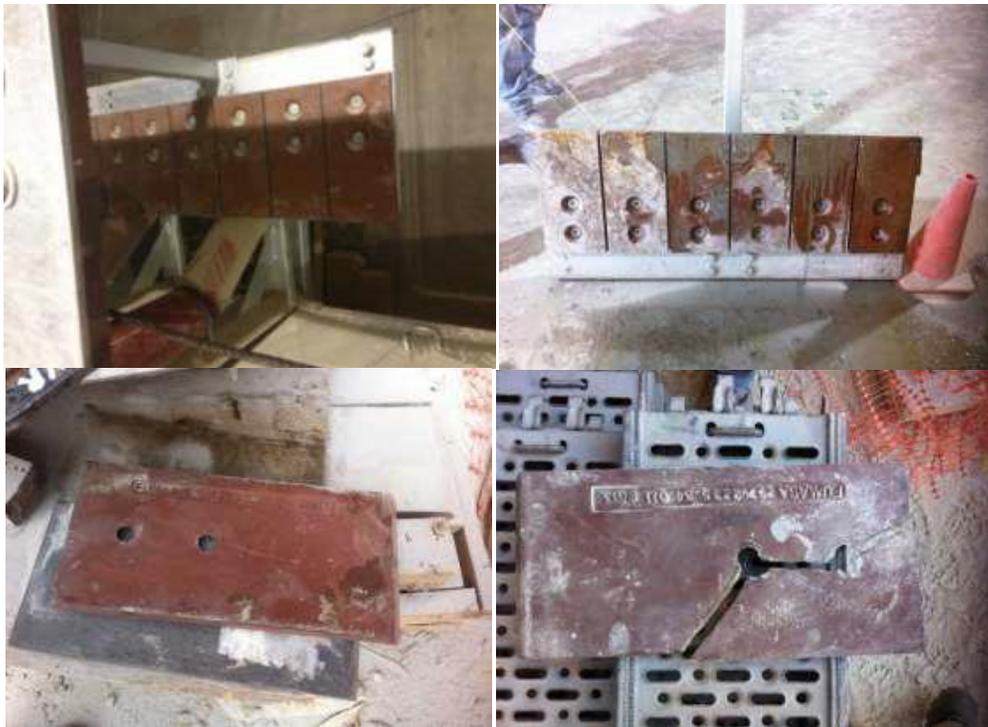
Valley Rubber's solution included redesigning the original Canoe Liner, including the dimensions, which reduced the number of liners along the three conveyor belts from 888 to 296 without exceeding the weight limitations for a one-person install. For every three original liners, one new Valley Rubber liner was installed in its place.

- 594 mm length instead of 194 mm for faster and easier installation while eliminating spillage.
- Beveled ceramic bricks at the bottom to maximize abrasion resistance at the critical point.
- Ceramic Cylinders on top to resist impact and provide long wear life.
- 3 slot holes make it a one-person install and the liner can be adjusted for normal wear.

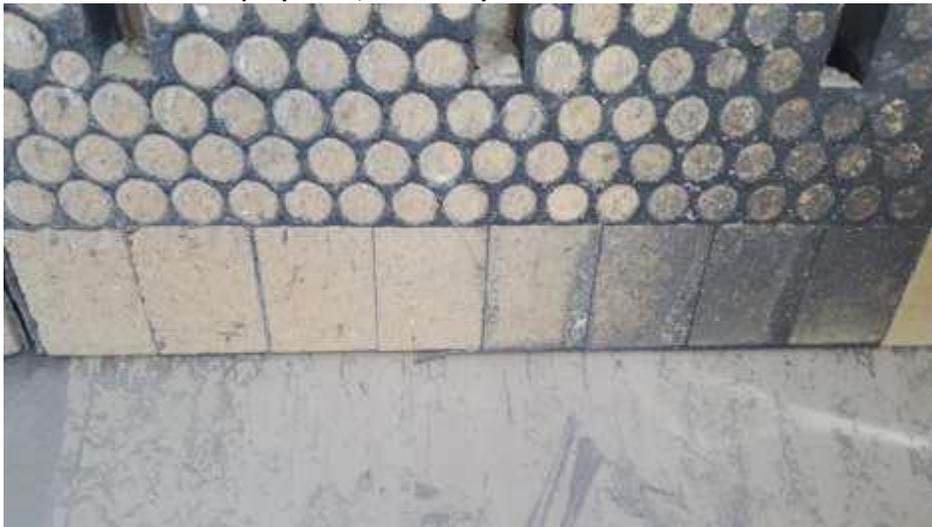
Canoe Liners After 155 Days (9'724,000 TON)

- In 419 days of work, only 160 Canoe Liners from Valley Rubber were replaced on all 3 conveyors (approximately 50%).
