Rubber-Ceramic Liners Exceed Wear Life Expectations

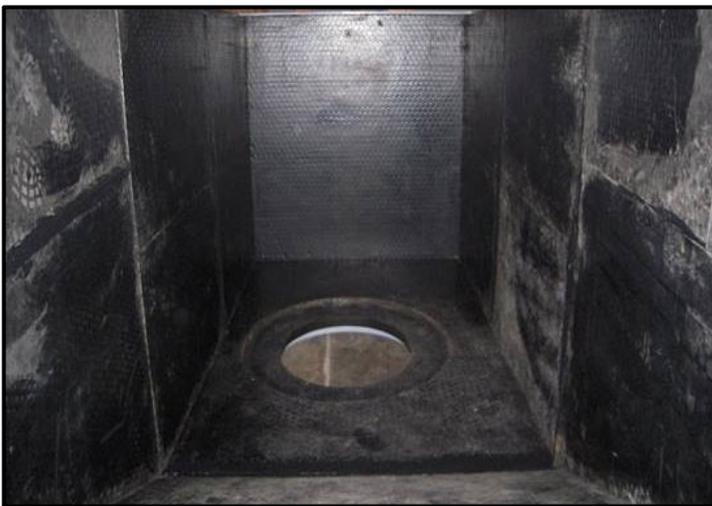
Launder Liners with Rubber-Ceramic held in place with internal magnets – no holes or hardware needed.

The entire launder was lined with 2" thick Rubber-Ceramic Liners which contained 1.25"x 1.25" ceramic cylinders embedded in V160, Valley Rubber's proprietary 60 durometer rubber.

- Attachment method: Side liners were custom manufactured with integrated powerful magnets and bottom liners were pinned down by side liners.
- Designed for easily replaceable "donut liner" to be changed periodically in the field to extend life of the rest of the launder.
- Custom 1" rubber ceramic liner for 28" OD x 64" tall discharge pipe.
- 20,000 gallons per minute, high wear and high impact situation.

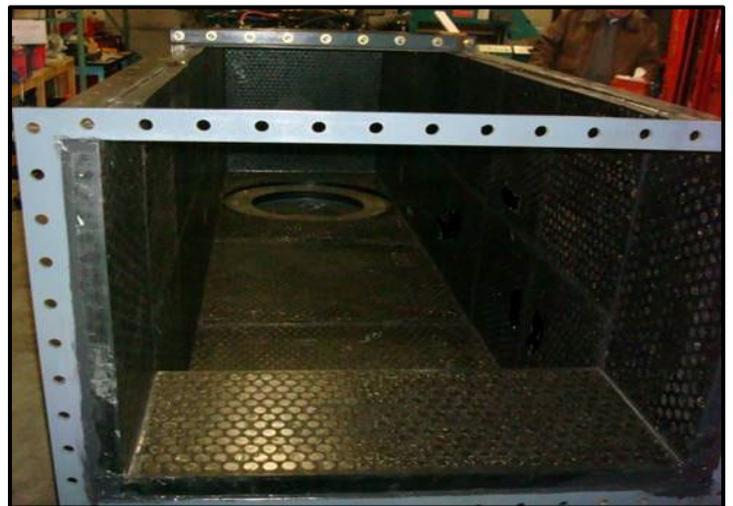
This design was customized for the application and included fast and easy installation.
