## SAG Screens Life Increased by 100%

### The Problem

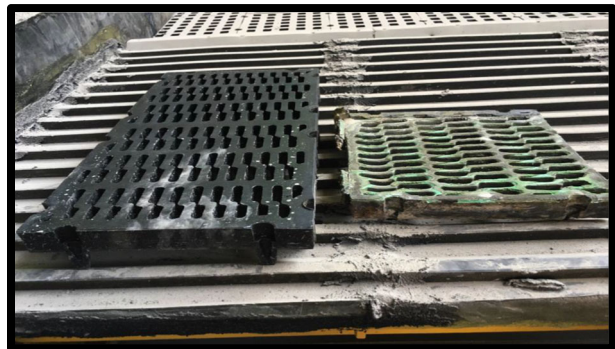
*Photo Above (Left) Valley Rubber Screen (Right) Screen used prior to Valley Rubber.*

Valley Rubber was asked to test its SAG Screens with a special design on the top deck. The length of each screen section was increased from 1' to 2' to not only reduce installation time but to provide greater open area. Once the test was completed with the customized screens, the goal of extending the length to 90 days was achieved with improved performance.
