Zero Failures with Valley Rubber Inflatable Liners

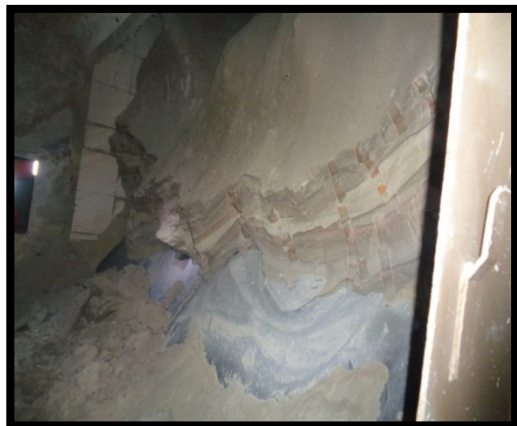
Photos above: Extreme plugging due to the failure of a competitor's inflation system.

A concentrator plant in Mexico experienced issues in their Secondary Chute after installing an inflatable system from a Valley Rubber competitor. The upper liners were leaking, creating buildup in the chute which in turn continued to plug due to the poor inflation system. The control boxes were not reliable and required regular maintenance.

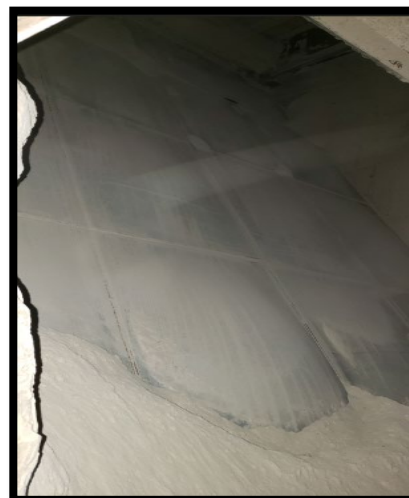
Photos above: Valley Rubber's Inflatable Liners after 1 year in operation without failures.

Our Inflatable Liners have been installed for over a year with zero failures. In the last inspection, the chute was found to be 90% clean with only a slight buildup above the installed Dead Bed Bars at its base. The use of Inflatable Liners prevents the need for clean out and maintenance. Since Valley Rubber's liners have been installed with our control box, all previous issues with plugging have been solved.

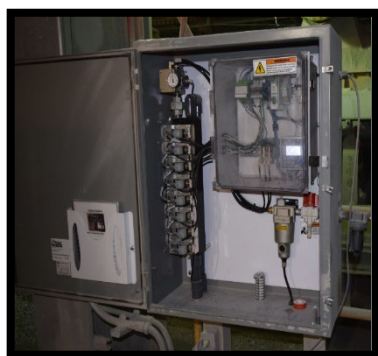
Photo Left: Valley Rubber Control Box

Control Box Cabinets can be further customized with:

- Additional air outlets
- Lighting
- Heating
- Outside Controls
- Operation Indicators
- Remote Controls
