# Secondary Belt Feeders

## Feeding - 14" Shot Rock at 800 TPH

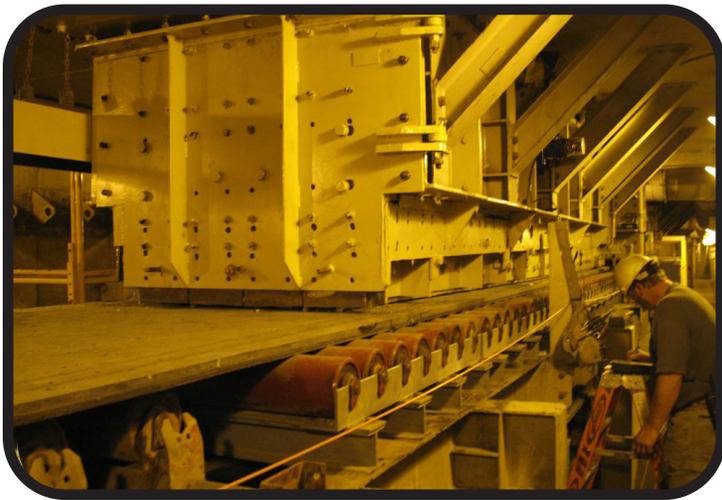
These feeders were fitted with an internal Loading Shoe and a Roller Table.

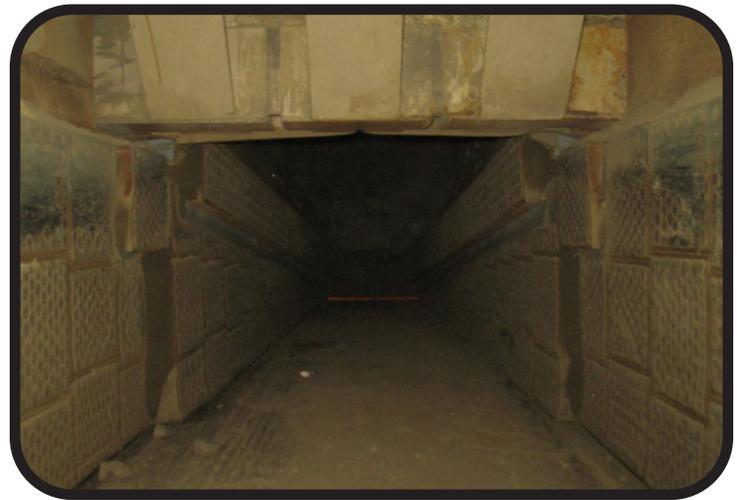
Internal Loading Shoe is fitted with ceramic liners on the Feeder Walls. Strike-off bar is overhead.

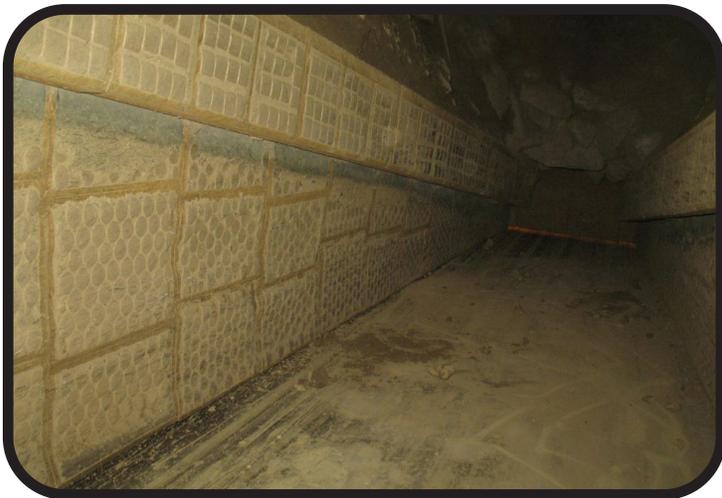
Looking toward the tail of the Loading Shoe. Top left is the engineered ceramic Deadbed Bar that protects the tapered floor of the Shoe.

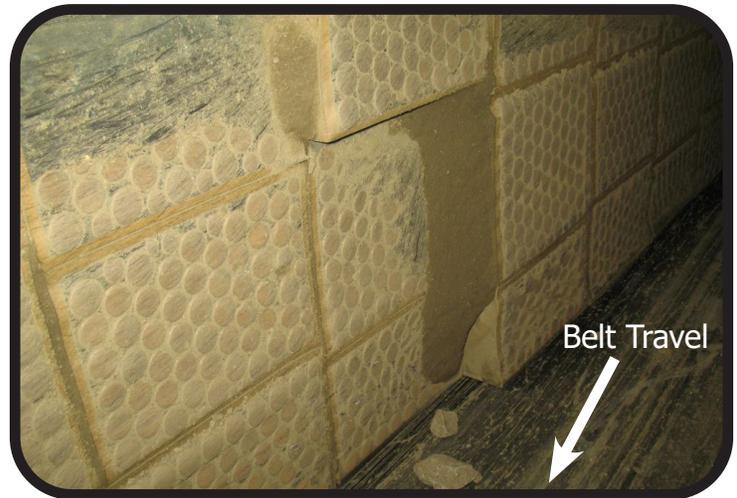
Special geometry is used effectively to relieve the side pressures on the liner package. The liners on the right hand side are inside the Shoe.

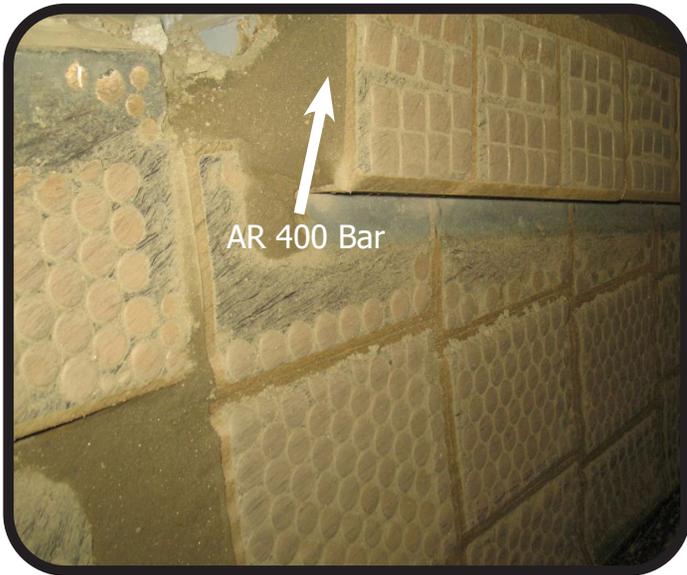
## Areas of Relief

The four areas of relief are: Tail to discharge, Belt to Deadbed, Deadbed to Shoe walls and walls to Discharge Canoe Zone. Ceramic cubes are used in the Deadbed liners, and cylinders in the wall sections. Notice the higher wear rate of steel perimeter bar (AR400) versus the ceramic.

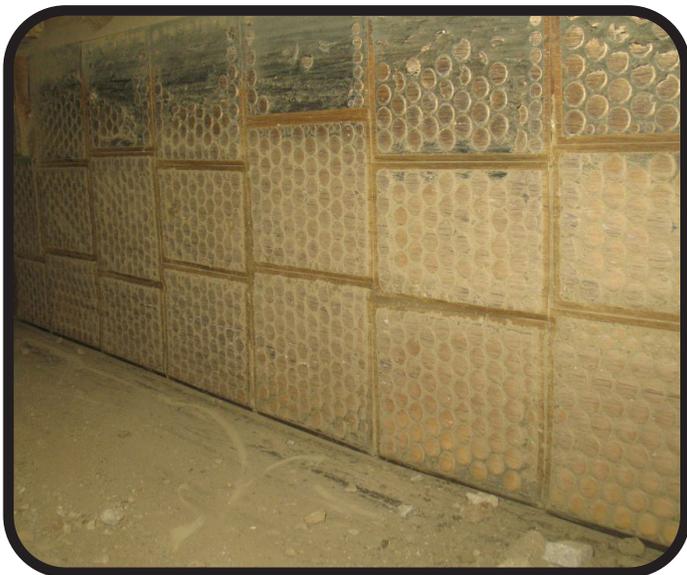
## Discharge Zone

The discharge zone liners are in excellent condition. These now have an operating lifecycle of 3-5 years. Previously, 2" Hardox 600 liners had a 90 day lifecycle.

The Rubber-Ceramic Liners in this area are held in place with two 1" mounting bolts, attached from the outside of the feeder. This provides a smooth face for uninterrupted material flow out of the feeder. Liner weights are held to manageable limits for removing by hand.

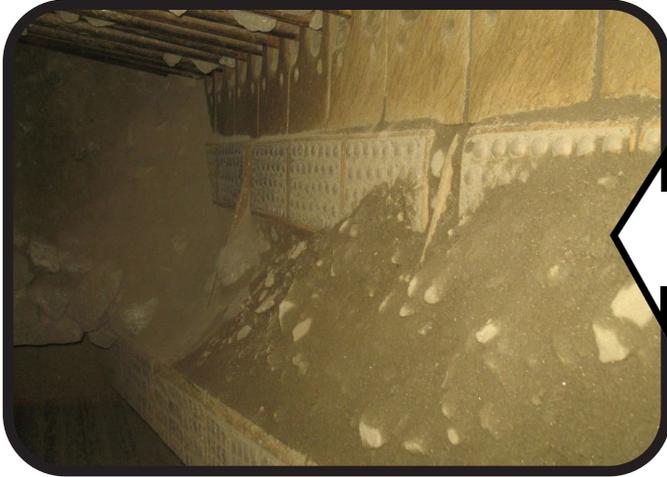
**Top view of the Loading Shoe; oversize rocks are wedged in the tail section. Proper Deadbed of material.**

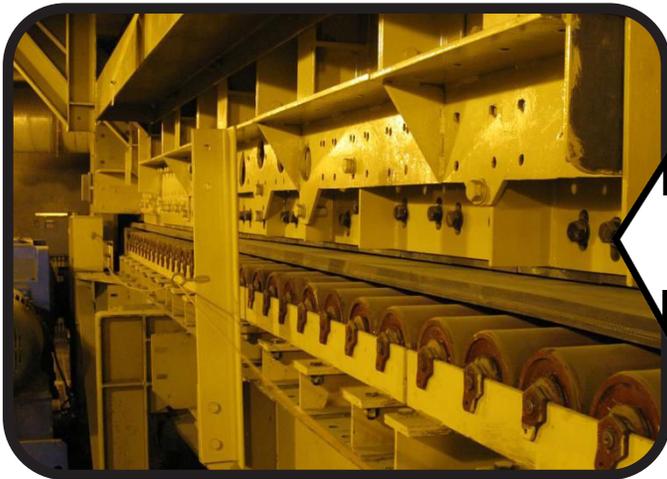
**In this example the outside walls were kept in place and a new Roller Table was fitted under the belt. These frames can be withdrawn by two men for roller servicing.**

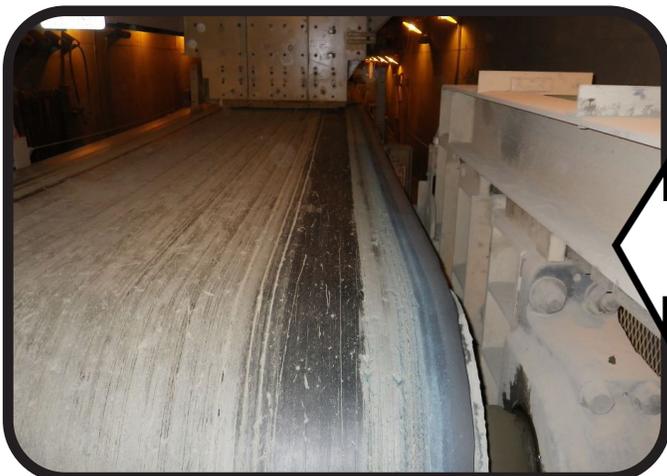
**Belt life is drastically improved from 90 days to now over three years...and still going! (This belt was not replaced during the installation of the new upgrade.) Notice the polished smooth top cover that tracks under the new ceramic liners in the Loading Shoe. After three years, it is still unknown how long these belts may ultimately last.**

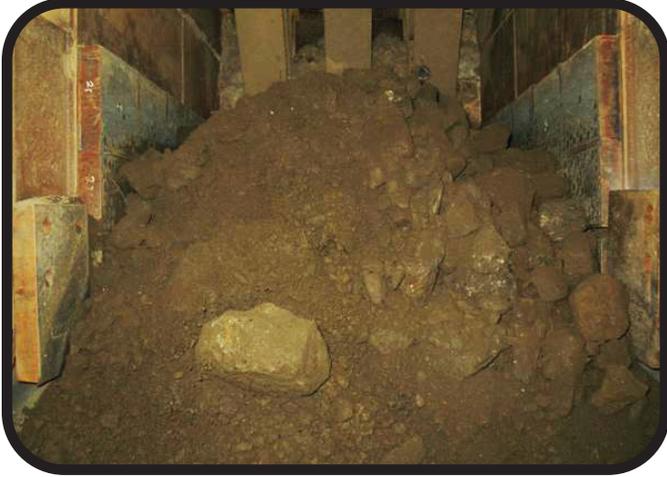
800 TPH of primary crushed ore.

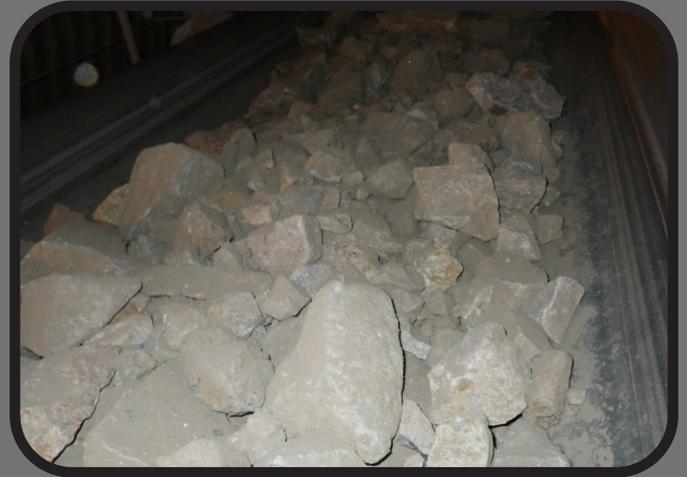
Approximately 1,600 TPH of SAG mill feed.  
The rocks are sharp, hard and angular.

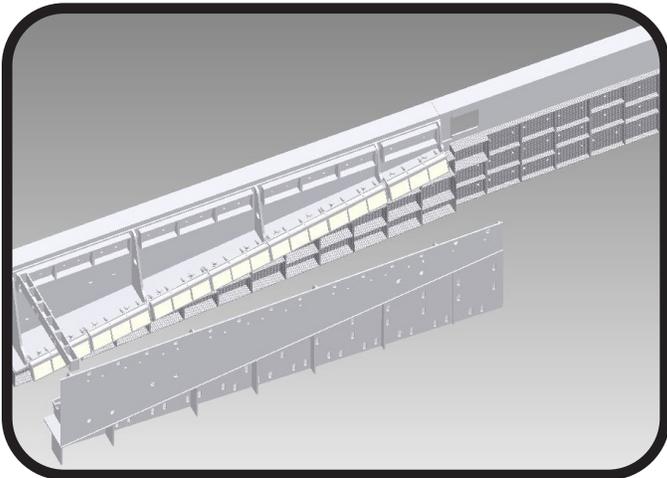
Engineering 3D Model.

(Left - 3D Model)

Top Floor Deadbed shelf and Ceramic Wear Bars

Internal double-tapered Loading Shoe

Top row Spile Box Shield Liners

Loading Shoe Ceramic Deadbed bars

Loading Shoe Ceramic Wall Liners

Strikeoff bar transition Ceramic Liners

Feeder discharge wall liners

All of these combined features allow for reduced shear forces and longer lifecycle component performance.

All three feeders were upgraded with the "insert" kit as depicted above in the Autodesk Inventor 3D model. The liner package had to be constructed to navigate around all the existing steel skirting bulkhead bracing, gussets and connection flanges. We standardized the liner sizes to minimize inventory requirements and make liner changes easier. The upgrade packages were installed on three separate feeder-down events.

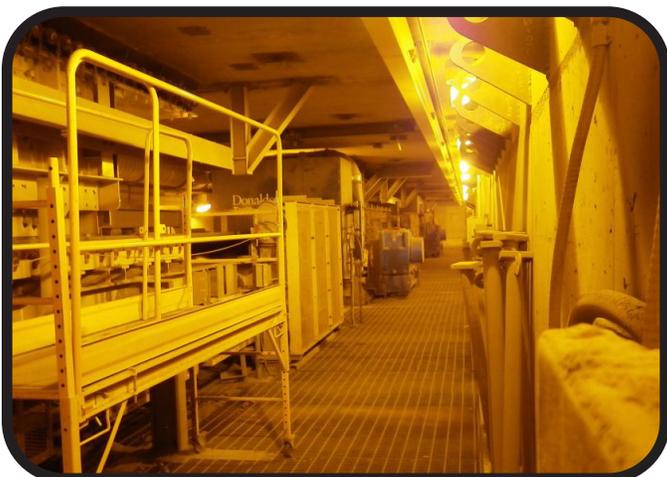
Three 800 TPH Feeders.

(Left gallery of three feeders under the primary surge pile.)

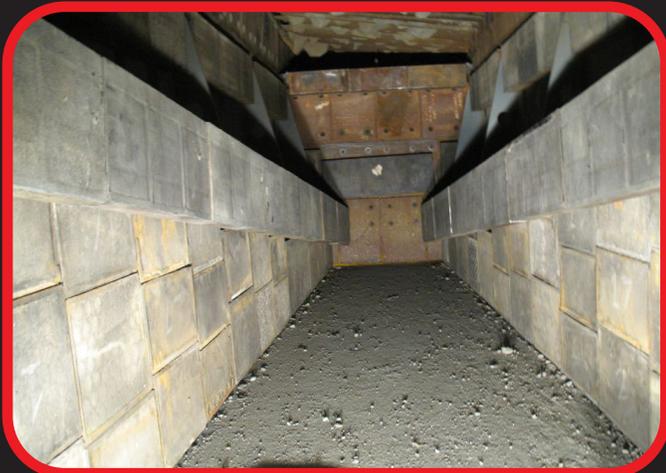
**Completion of Installation**

**(Left)** The liners on the back wall were left as steel on this retrofit. Notice the rubber skin is covering the ceramic embedded liners in both the Deadbed Bars and the Loading Shoe Wall liners. These liners are custom designed for this feeder application and specific internal steel gusseting, attachment hardware points and retaining steel for the ceramic. Overhead, 2" diameter splice bars.

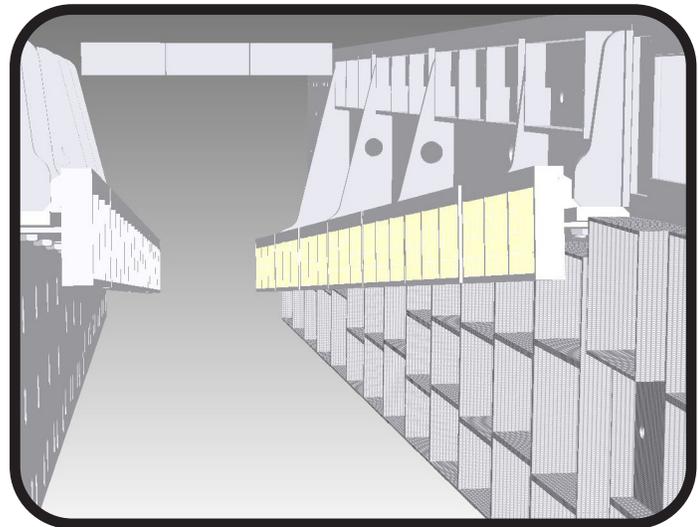
**Autodesk Inventor 3D Model**

**(Right)** All of the components are modeled in 3D, eliminating interference fit issues during installation. Loading Shoe Platform is fabricated 1" plate.

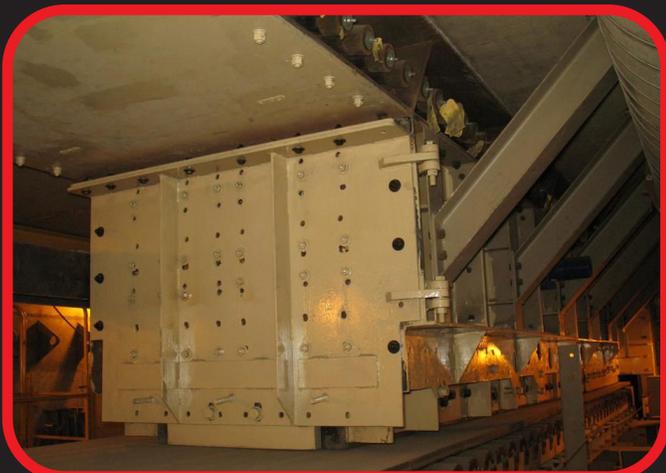
**Converted Feeder viewed from the back**

**(Left)** The top of the photo is the plate floor, installed to shorten the excessive length of the feeders. Back door was slightly modified. New Loading Shoe walls can be seen inside the bottom of the trimmed feeder walls. The new Roller Table now evenly and fully supports the belt, eliminating the pinching of material under the liners.
