Reduced Maintenance Costs, Increased Production

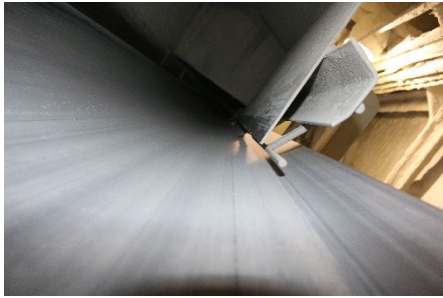
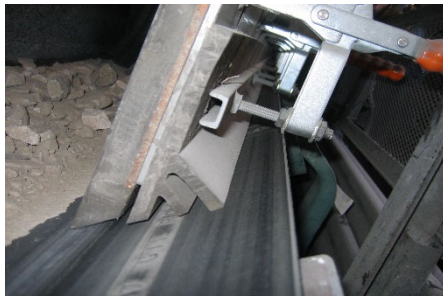
It is common to see either a piece of conveyor belt bolted to the rear of the canoe, or a slab of rubber bolted in the same fashion. Unable to be adjusted, these quick fixes are time consuming and rarely maintained, causing continued spillage and dust issues. The previous system pictured resulted in costly fines, excessive maintenance, loss of production and structural weight load concerns due to spillage.

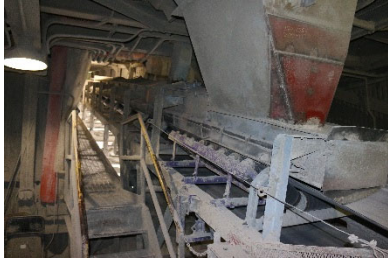
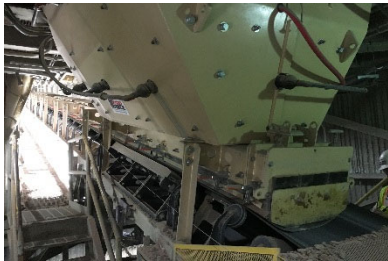
Solution: The TailSeal-Kit utilizes a system that incorporates three molded rubber blades that are adjustable using stainless steel t-handled screws. This allows for three points of contact to create a seal on the belt. Then for ease of inspection and maintenance, the system is hinged for access.
