Haul Truck Liners

We're the **Industry Leaders** in lining systems that will lower your operating cost.

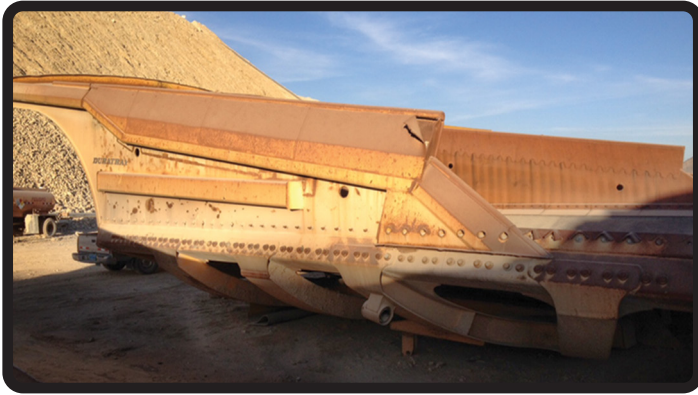
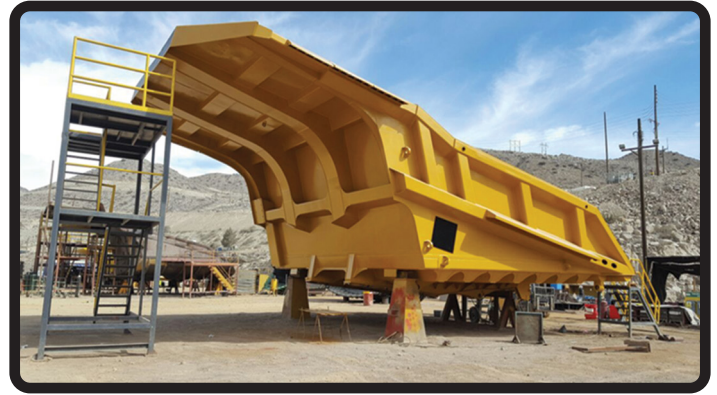
Duratray Conversions

Valley Rubber can rebuild Duratray boxes and return them to serve as a maintenance-free system.

- Duratray boxes taken out of service due to excessive maintenance costs.
- Cables reached a point where they could not be tensioned any further.
- Tension cables would break causing damage to the rubber liner and the cables would require a long period of time to replace.
- When a hole developed in a liner, the whole bed liner had to be replaced
- Rubber Liners with patched holes were not feasible.
- Cables would have to be regularly tensioned, replaced or repaired.

- Modifications were made to the truck box frame.
- The center of gravity was lowered giving extra stability to the truck.
- A steel structural support plate was added to the existing framework.
- Modular steel-backed Rubber Liners were bolted to the floor.
- Liners were abrasion resistant and structurally sound.
