Peru Canoe Liners

A new concentrator plant was built in a Peruvian mine where an important technological improvement was introduced to aid in feeding the two concentrators. Currently 74,800 tons-per-day are conveyor-fed to the Intermediate Dome, with a projected increase to 160,000 tons-per-day.

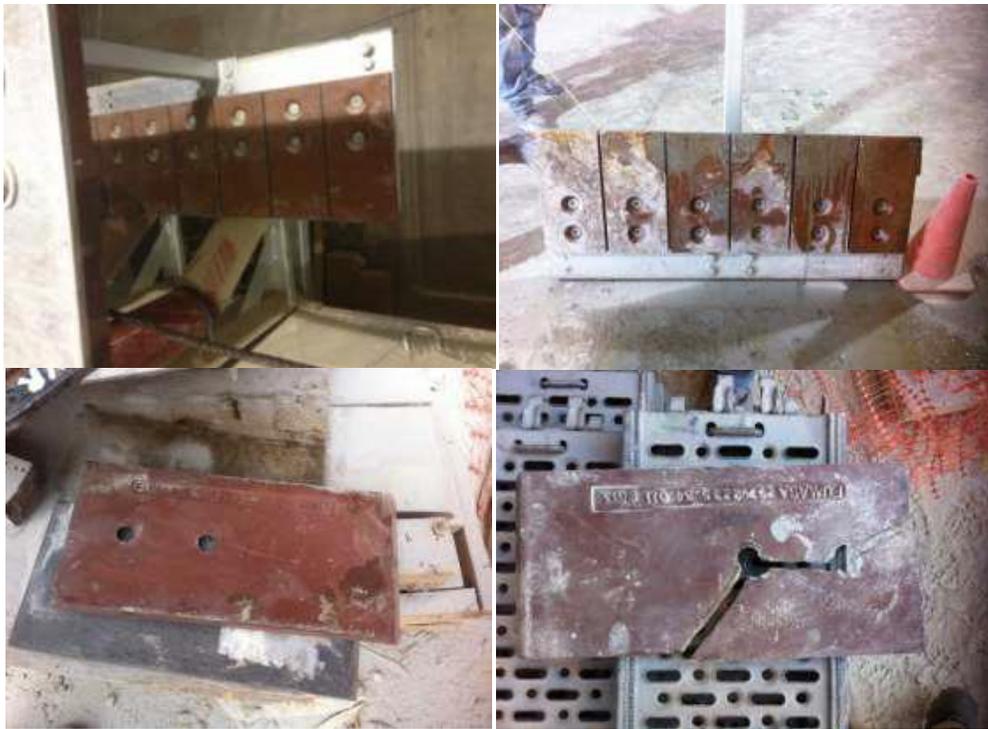
Valley Rubber's solution included redesigning the original Canoe Liner, including the dimensions, which reduced the number of liners along the three conveyor belts from 888 to 296 without exceeding the weight limitations for a one-person install. For every three original liners, one new Valley Rubber liner was installed in its place.

- 594 mm length instead of 194 mm for faster and easier installation while eliminating spillage.
- Beveled ceramic bricks at the bottom to maximize abrasion resistance at the critical point.
- Ceramic Cylinders on top to resist impact and provide long wear life.
- 3 slot holes make it a one-person install and the liner can be adjusted for normal wear.

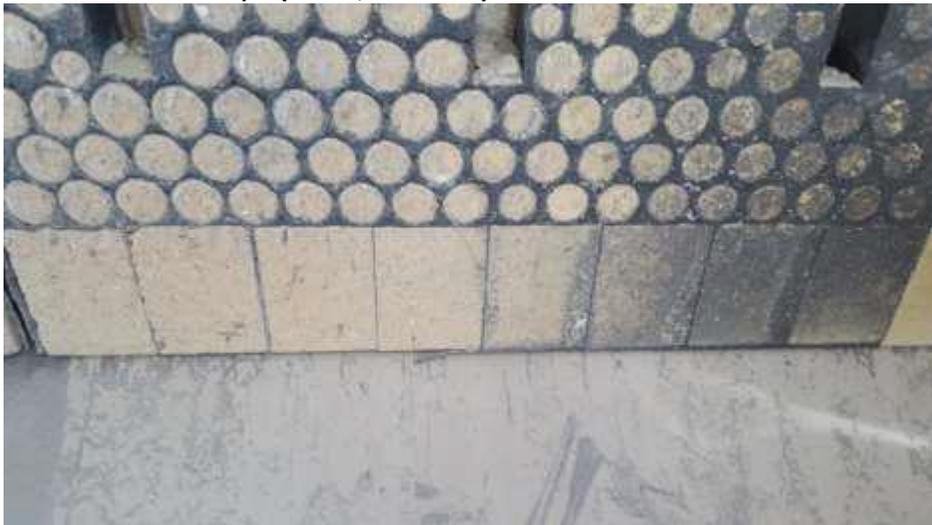
Canoe Liners After 155 Days (9'724,000 TON)

- In 419 days of work, only 160 Canoe Liners from Valley Rubber were replaced on all 3 conveyors (approximately 50%).

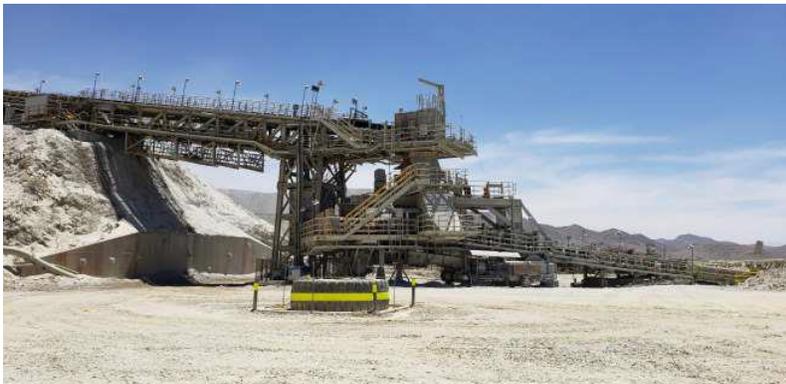
Leaching-Canoe Liners Area

Transfer Point #15 Leaching Area

The canoe liners from the crushing area were initially placed as a test in transfer # 3 of the Leaching area. Although the material is a larger diameter and pass 8.350 tons per hour, the trial was successful.

In the chute discharge zone or explosion zone, where steel canoe liners lasted from 20 to 30 days, Valley Rubber liners lasted 3 months. This discharge area represents 15% of the total chute, the other 85% has not been replaced, and after 8 months they are still working well.

The Canoe Liners have been placed in transfers # 15 and # 30, and in both cases they are producing similar positive results as transfer #3.
