Rubber-Ceramic Liners Exceed Wear Life Expectations

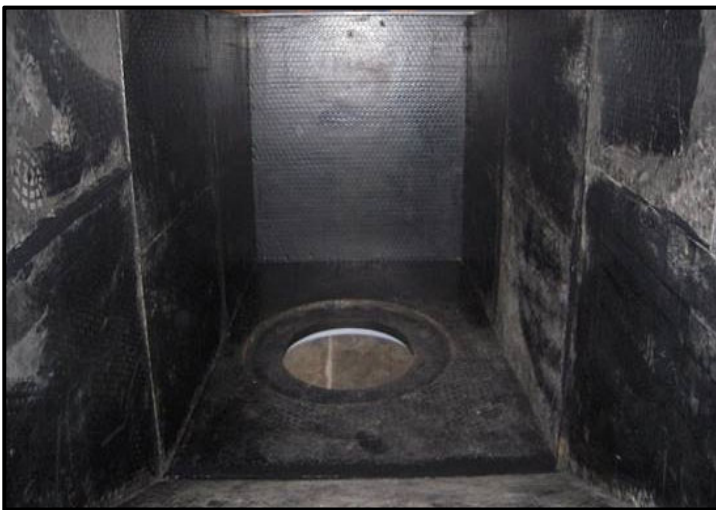
Launder Liners with Rubber-Ceramic held in place with internal magnets – no holes or hardware needed.

- Attachment method: Side liners were custom manufactured with integrated powerful magnets and bottom liners were pinned down by side liners.
- Designed for easily replaceable "donut liner" to be changed periodically in the field to extend life of the rest of the launder.
- Custom 1" rubber ceramic liner for 28" OD x 64" tall discharge pipe.
- 20,000 gallons per minute, high wear and high impact situation.

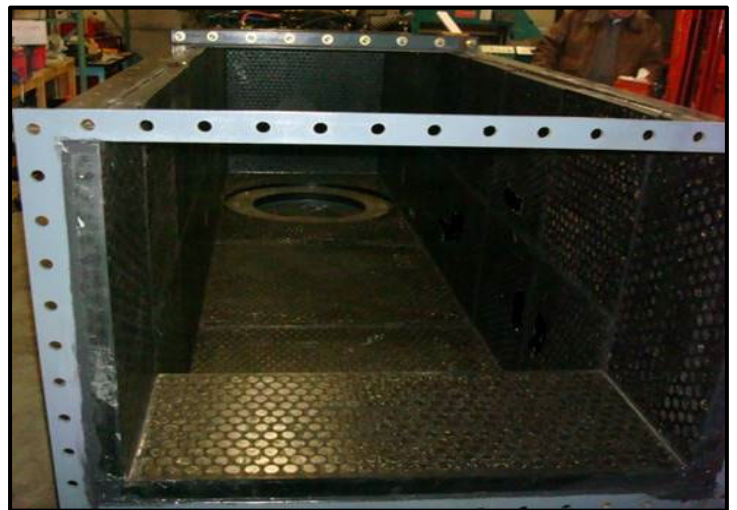
This design was customized for the application and included fast and easy installation.
