## SAG Screens Life Increased by 100%

### The Problem

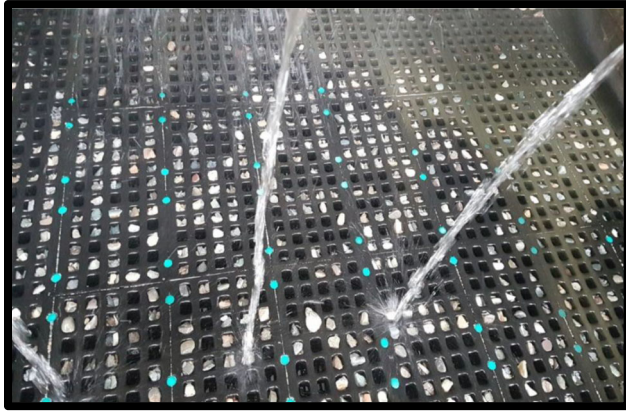
A Chilean operation had a SAG screening system in place that only lasted 45 days with continuous failures. When pegging occurs, the proper operation, speed, stroke, shaft rotation, and machine balance should be checked to ensure it is optimized for the application. If machine operation has been verified, then a change to the screen surface should be considered. This type of problem requires a specific screening solution.

*(Photo Above)- Before the screen pegged with particles lodged in the openings.*

Valley Rubber was asked to test its SAG Screens with a special design on the top deck. The length of each screen section was increased from 1' to 2' to not only reduce installation time but to provide greater open area. Once the test was completed with the customized screens, the goal of extending the length to 90 days was achieved with improved performance.

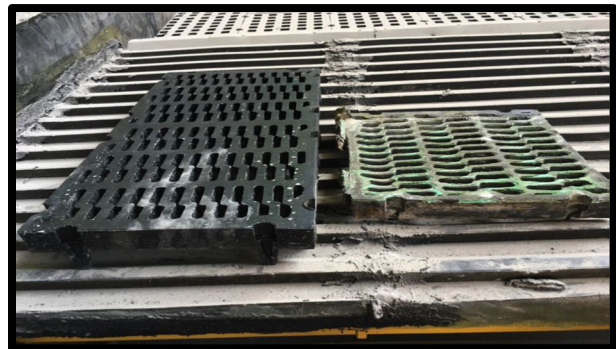
*Photo Above (Left) Valley Rubber Screen (Right) Screen used prior to Valley Rubber.*

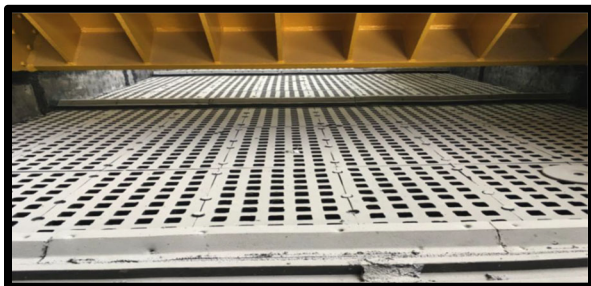
**Valley Rubber's SAG screens lasted 100% longer with no pegging.** The customer considered the test a success and now Valley Rubber is their main supplier of SAG screens.
