Reduced Maintenance Costs, Increased Production

Prior to using Valley Rubber BeltSeal-Kits, operations have experienced the following issues: **excessive maintenance, MSHA and EPA violations, followed with the inability to meet full production.** Below are four illustrations demonstrating how BeltSeal-Kits and their components have provided solutions to common plant issues.

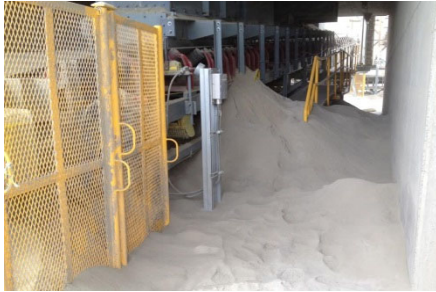
An operation's load zone was not properly supported which allowed the belt to porpoise between the impact idlers. Significant spillage, dust and maintenance resulted from this issue. The Load Zone was running 3000TPH with two Cone Crushers at 1,100hp each, crushing 14" minus material to ¾" minus. A three-man crew spent six hours twice a week cleaning up the spillage.

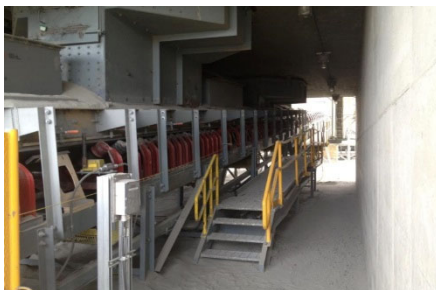
Solution: Valley Rubber's solution included adding BeltSeal Clamps with DoubleLip DustSeal skirting and Impact Idlers that are spaced tighter together. Adjustable BeltStabilizer Brackets and Bars were installed between the troughing idlers. A BeltSeal-Kit and TailSeal-Kit were installed, and the three-man cleanup crew now only had to come once every two weeks.

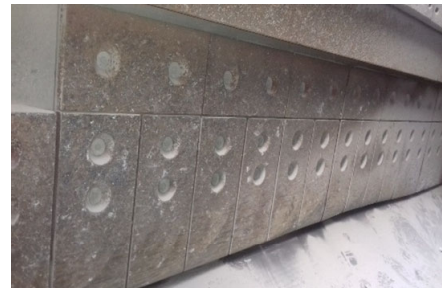
Steel liners in a Latin American operation were only lasting 45 days. There was an increased cost-per-ton, along with spillage, dust and noise.

Solution: Rubber Ceramic liners were installed and after fifteen months are still in operation. Canoe Liners simplify installation, adjustment and alignment. They are anchored to the canoe frame using T-Bolts that are embedded within the Canoe Liner.

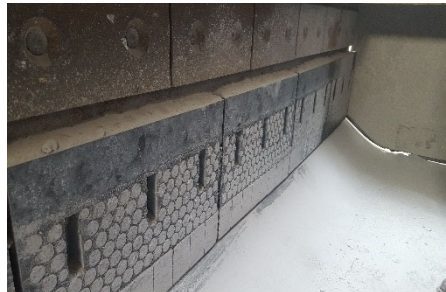
Typical seals are sold in large rolls that are hard to handle and ineffective.

Solution: DustSeals are effective and easy to handle and are supplied in 10' lengths. Valley Rubber offers DoubleLip and TripleLip-DustSeals that are designed to work in conjunction with our BeltSeal components.
