Beneficial Savings & Safety

A new concentrator plant was built in a Peruvian mine where an important technological improvement was introduced to aid in feeding the two concentrators. Currently 74,800 tons-per-day are conveyor-fed to the Intermediate Dome, with a projected increase to 160,000 tons-per-day.

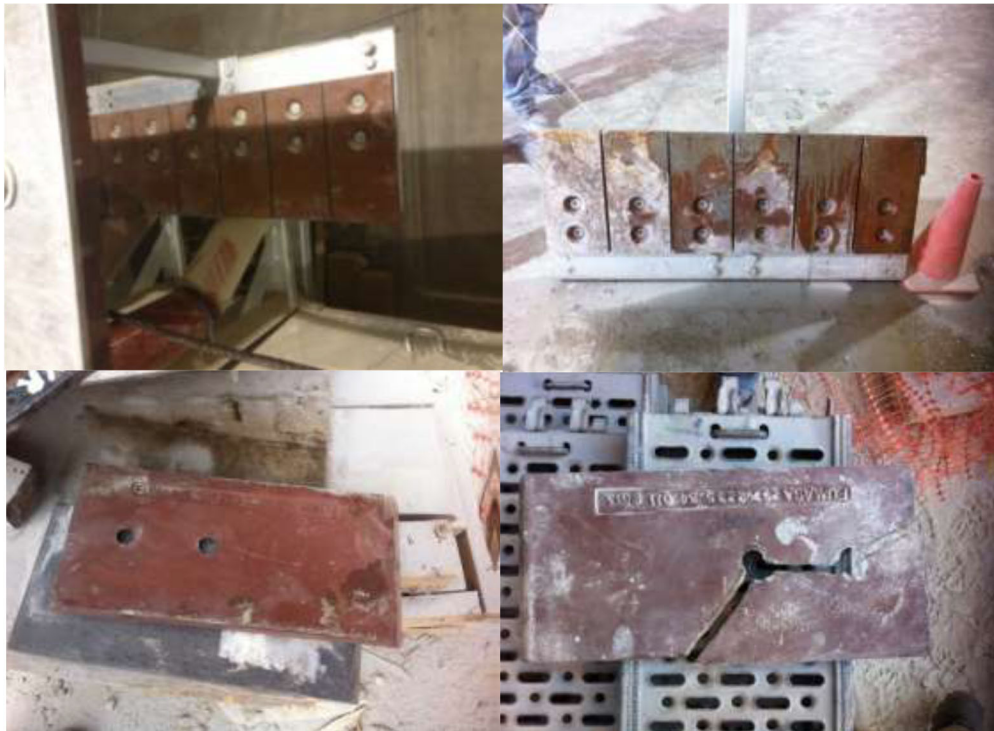
Valley Rubber's solution included redesigning the original Canoe Liner, including the dimensions, which reduced the number of liners along the three conveyor belts from 888 to 296 without exceeding the weight limitations for a one-person install. For every three original liners, one new Valley Rubber liner was installed in its place.

Characteristics of Valley Rubber Canoe Liners:

- 594 mm length instead of 194 mm for faster and easier installation while eliminating spillage.
- Beveled ceramic bricks at the bottom to maximize abrasion resistance at the critical point.
- Ceramic Cylinders on top to resist impact and provide long wear life.
- 3 slot holes make it a one-person install and the liner can be adjusted for normal wear.

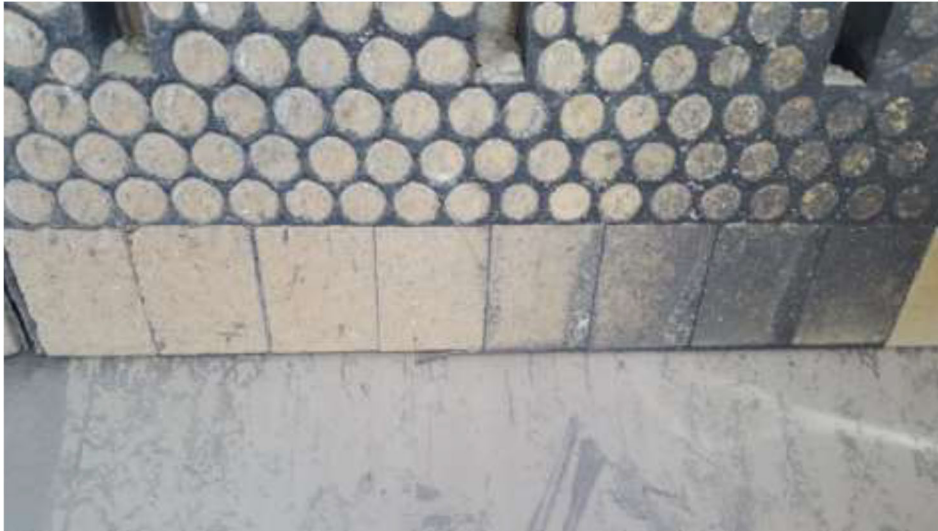
Canoe Liners After 155 Days (9'724,000 TON)

- In 419 days of work, only 160 Canoe Liners from Valley Rubber were replaced on all 3 conveyors (approximately 50%).

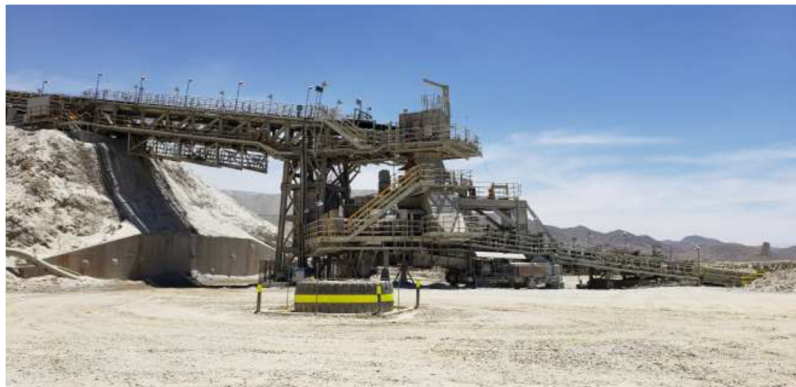
Leaching-Canoe Liners Area

Transfer Point #15 Leaching Area

The canoe liners from the crushing area were initially placed as a test in transfer # 3 of the Leaching area. Although the material is a larger diameter and pass 8.350 tons per hour, the trial was successful.

In the chute discharge zone or explosion zone, where steel canoe liners lasted from 20 to 30 days, Valley Rubber liners lasted 3 months. This discharge area represents 15% of the total chute, the other 85% has not been replaced, and after 8 months they are still working well.

The Canoe Liners have been placed in transfers # 15 and # 30, and in both cases they are producing similar positive results as transfer #3.
