## **Eliminating Unscheduled Shutdowns**

## **The Problem**

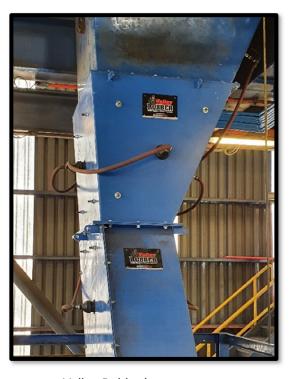
Valley Rubber's new system

(Right) Before Valley Rubber's system was installed.

Valley Rubber performed a 3D scan of the existing structure to determine the best course of action for a new system design. The chute was completely redesigned, utilizing Inflatable Liners in all critical areas, to promote material flow and mitigate build-up.

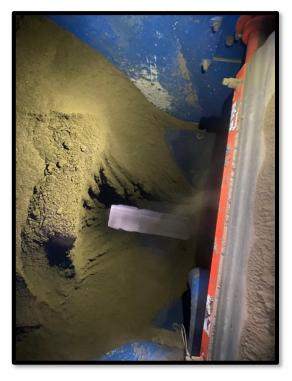
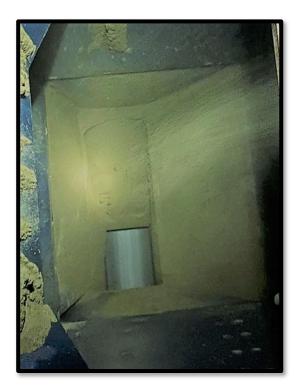
Before After

Below is an example of two images taken where the material moisture content was 12%. Notice the difference between the Valley Rubber inflatable system versus the alternative coating system.

At the time of this publication, 120,846.72 tons of copper concentrate had traveled through the Valley Rubber lined chute with inflatables, where the average material moisture content is 10% but can be at times higher than 12%. Since the implementation of the new liners, the plant has surpassed a 90 day period of uninterrupted work.
