SAG Screens Life Increased by 100%

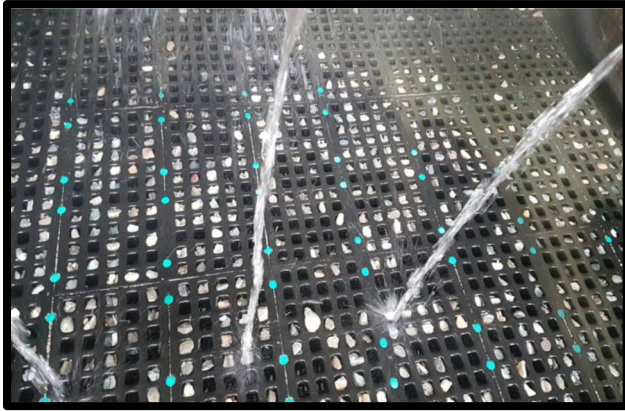
(Photo Above)- Before the screen pegged with particles lodged in the openings.

A Chilean operation had a SAG screening system in place that only lasted 45 days with continuous failures. When pegging occurs, the proper operation, speed, stroke, shaft rotation, and machine balance should be checked to ensure it is optimized for the application. If machine operation has been verified, then a change to the screen surface should be considered. This type of problem requires a specific screening solution.

Valley Rubber was asked to test its SAG Screens with a special design on the top deck. The length of each screen section was increased from 1' to 2' to not only reduce installation time but to provide greater open area. Once the test was completed with the customized screens, the goal of extending the operational life to 90 days was achieved with improved performance.

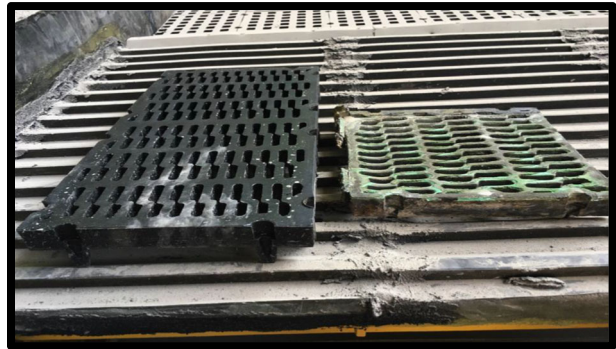
Photo Above (Left) Valley Rubber Screen (Right) Screen used prior to Valley Rubber.
