The Issue

A Peruvian operation sought to enhance the longevity of their Primary Crushing Belt Feeder lining system composed of high Brinell bimetallic liners. The frequent replacement every six months was cumbersome, and the liners caused damage to the belt.

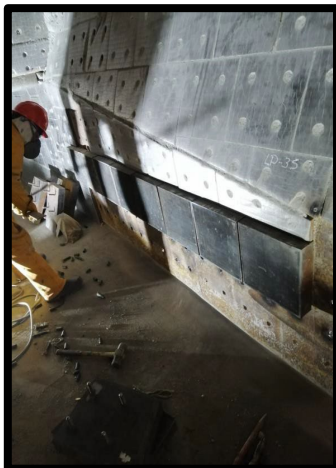
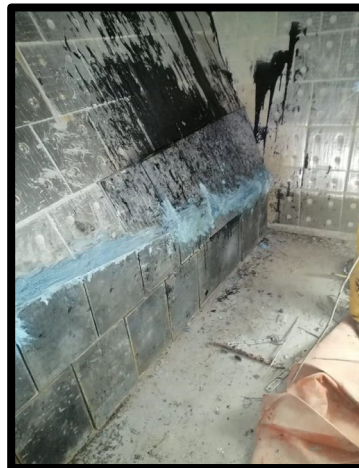
Installation Photos

Valley Rubber developed a trial installation for a Rubber-Ceramic liner system in the lower section of the Belt Feeder walls, targeting the area with the highest wear rates. The objective was to:

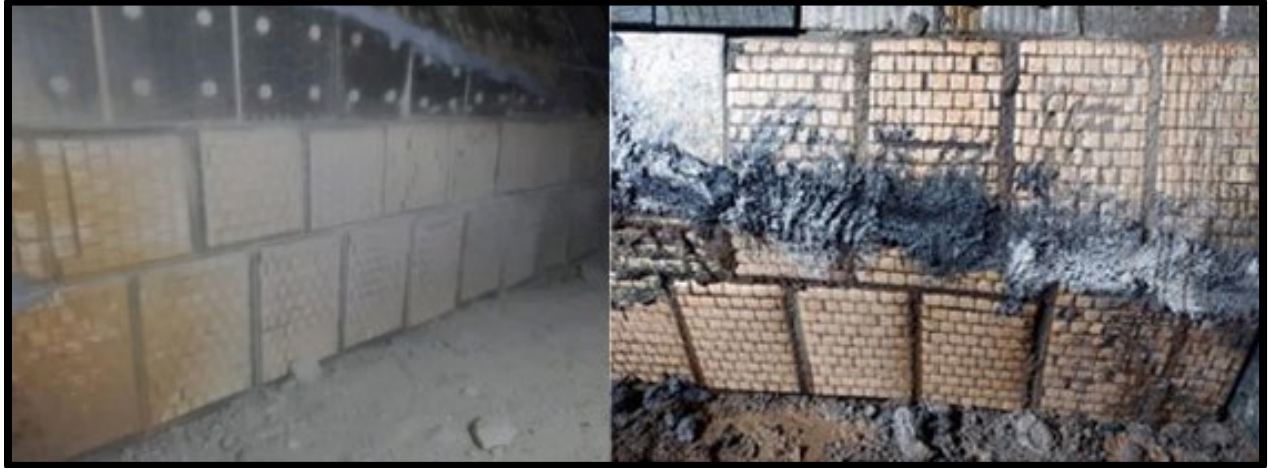
After two months of operation, an inspection found the Rubber-Ceramic Liners to be in excellent condition, and they were expected to exceed the life-time offered. Following two months of operation, an inspection showed the Rubber-Ceramic Liners to be in excellent condition, and they were anticipated to surpass the agreed-upon lifetime. **After 17 months of operation**, an inspection confirmed the liner's sustained outstanding condition, surpassing the initially outlined 12-month lifetime.

Left: Liners after two months; Right- Liners after 17 month and still in excellent condition.

The successful trial prompted the operation to order a second set of Rubber-Ceramic Liners specifically for the Belt Feeder walls that endure the most significant wear. GRT/Valley Rubber remains dedicated to **sustaining** and **enhancing** the achieved results.
