The Problem

The Solution

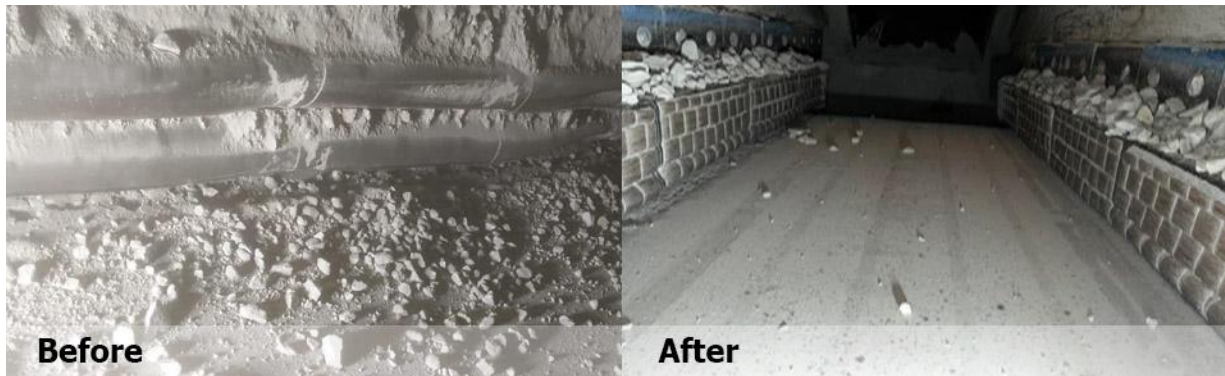
A mining operation in Mexico faced frequent wear, material spillage, unplanned maintenance, and increased labor on a secondary feeder. Competitor-installed impact bars—each weighing 35–45 kg—damaged feeder walls and posed a risk of belt cuts when shelves were lowered, lasting only 5 months.

GRT Rubber (Valley Rubber) installed Rubber-Ceramic Double Impact Bars reinforced with steel plates for added rigidity and belt protection. Each 32 kg bar was spaced just ¼” apart to ensure optimal performance.

The Rubber-Ceramic Impact Bars help eliminate spillage, protect feeder sidewalls, extend equipment life, reduce installation labor, and promote center loading. ***By switching to our Rubber-Ceramic Impact Bars, the mine extended wear life by 380% from just 5 months to nearly two years of performance.*** Rubber-ceramic is an ideal choice for its quick installation, superior abrasion resistance, and noise-reducing properties.
