Primary Belt Feeders

Our Primary Belt Feeders can replace your apron/pan feeders

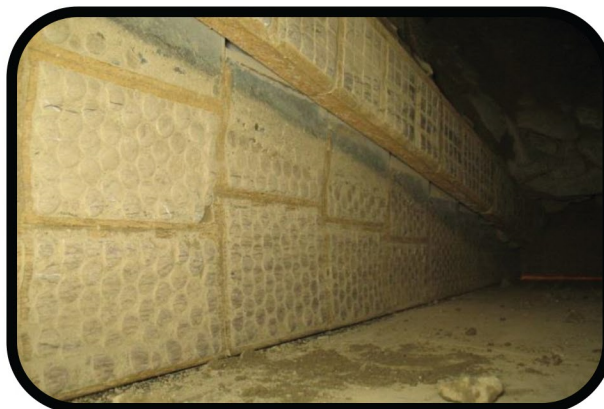
Existing loading shoe in a 60" Feeder taken at 50 weeks

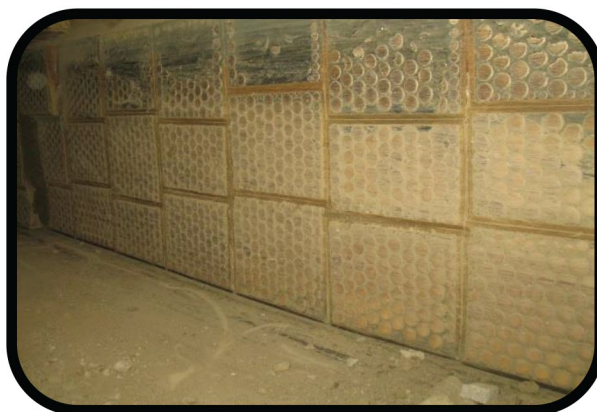
Discharge wall in a 60" feeder

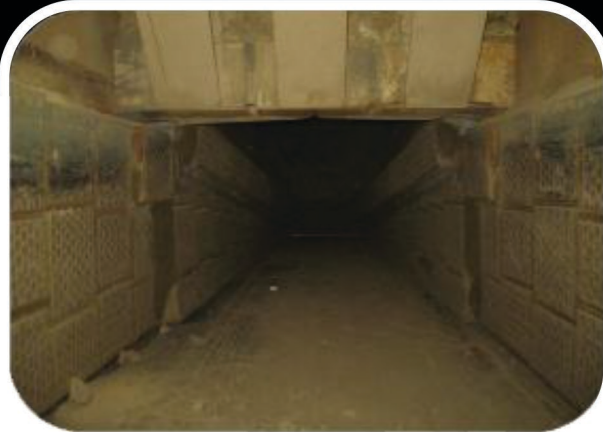
Strikeoff Zone

One of the key features of the Feeder System is the modulating of forces within the feeder drawdown compartment into the loading shoe. Specific to this is the proper placement and geometric design of the liners in the flow-zone surrounding the strikeoff bar. This is critical if liner performance and belt life are to be maximized. The optimum configuration allows for material to move with the belt and not be pulled and/or sheared by the belt.

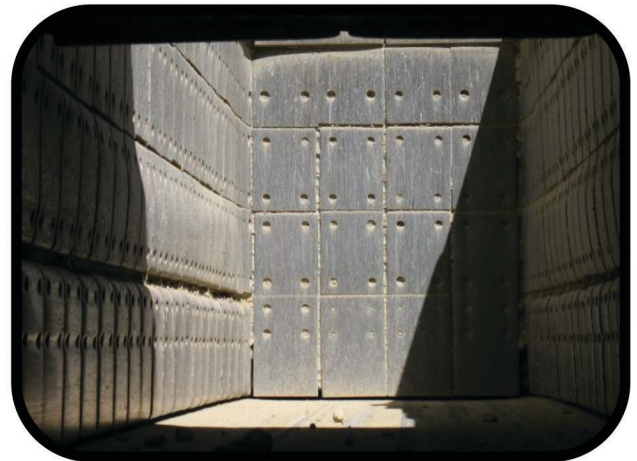
(Above) 60" feeder during a 2008 maintenance outage. Notice the straight walls that allow rock to be loaded down hard onto the belt. Liner lifecycle in this area is about 90 days.

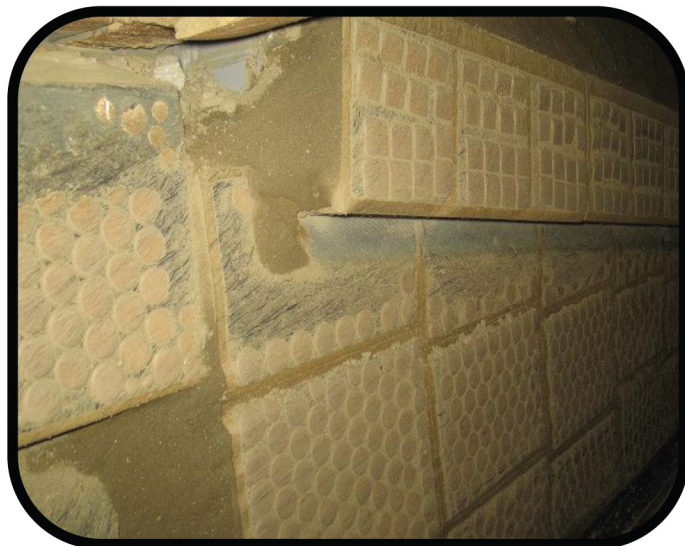
Rubber and Ceramic (2" thick)

Pictured Above; 114 Weeks and still running...

Cost/ft² ~ = \$482.00

In the location pictured, the custom designed Rubber/Ceramic liners are over 7 times more cost effective than the previous steel liners. This does not take into account labor or hardware replacements for the steel liners, such as countersink bolts.

Ceramic @ \$4.22/week
