Rubber-Lined Haul Trucks Have Zero Box Maintenance After 5 Years!

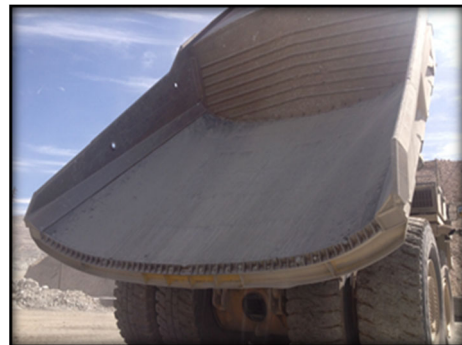
Komatsu 930 Haul Truck, five years of using rubber liners and still in service.

Starting in 2012, Valley Rubber began to install 6" thick rubber liners in Komatsu 830 and 930 Haul Trucks with the intention of extending the useful life of the truck box to five years without performing maintenance or repairs, except the monthly routine inspections and the rotation of the central pieces of the lining every three years. The addition of the rubber liners did not affect the load factor.

It is evident that rubber-lined trucks in this operation had superior performance when compared to steel-lined trucks. The trucks that were first lined in 2012 have hauled as many as 10,898,400 tons...all with zero box maintenance!
