Rubber-Lined Haul Trucks Have Zero Box Maintenance After 5 Years!

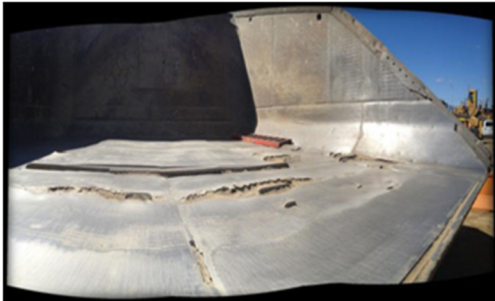
Common fractures and liner damage in truck boxes with steel liners.

- Steel lining will be installed and changed more than 2.5 times.
- There will be ongoing maintenance on both the liners in the box and the chassis of the truck due to impact and wear.
- Cost of Repair: Between \$80,000 - \$100,000.
