BeltSeal Solutions

Why do you need a BeltSeal-Kit

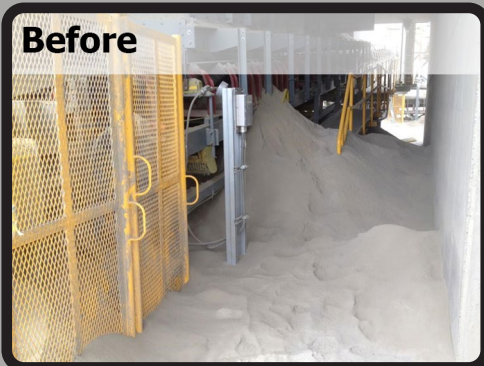
(Before) The Load Zone was not properly supported which allowed the belt to porpoise between the impact idlers. Significant spillage, dust and maintenance resulted from this issue.

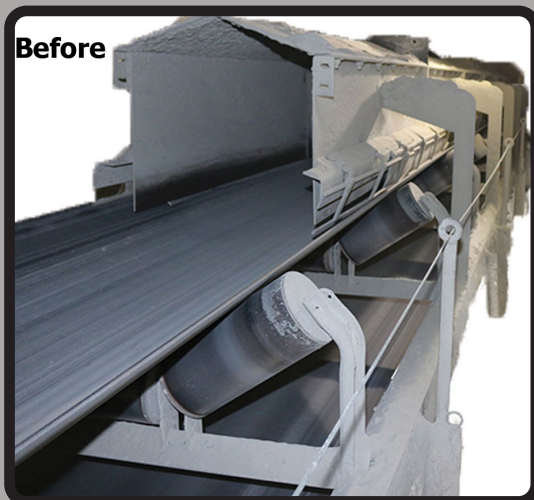
The original design allowed material and dust to escape between the belt and canoe.

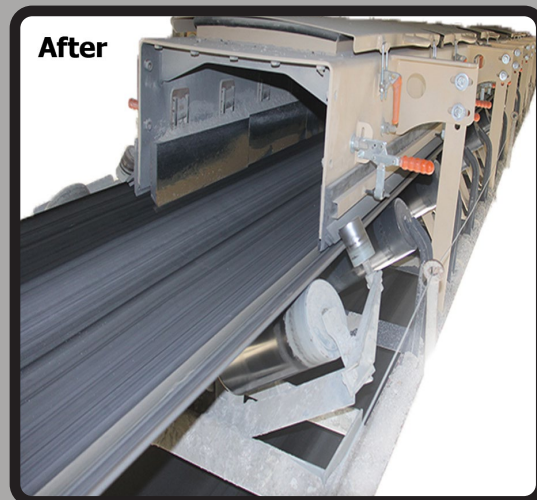
The new design includes all of Valley Rubber's **BeltSeal-Kit** components.

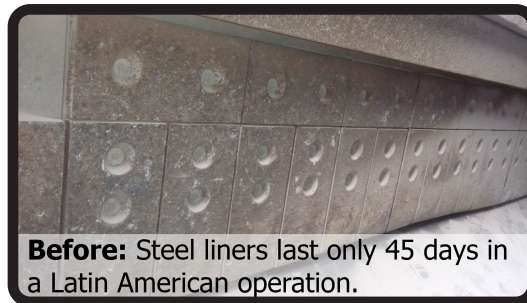
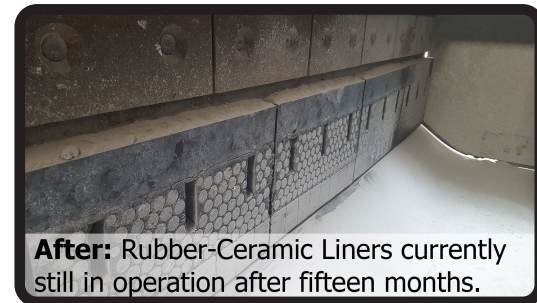
We have designed our Canoe Liners to simplify installation, adjustment and alignment. They are anchored to the canoe frame using T-Bolts that are embedded within the Canoe Liner.

- In load-zones that have a high tonnage rate, our Canoe Liners significantly reduce spillage, dust and wear by not only centering the material on the belt, but increasing the life of the belt with its drag free design.
- Designed specific to your application, then custom manufactured.
- Each metal-backed Canoe Liner comes with the ability to adjust the height to fit your conveyor belt.

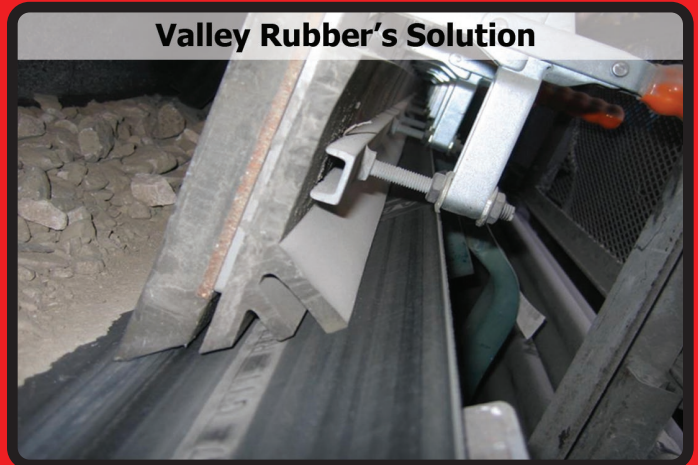
RubberLine Canoe Liner is beveled to match the belt angle. Notice the three points of contact on the **DoubleLip-DustSeal**. The **BeltSeal Clamps** easily and safely open to adjust our **DoubleLip-DustSeal**.

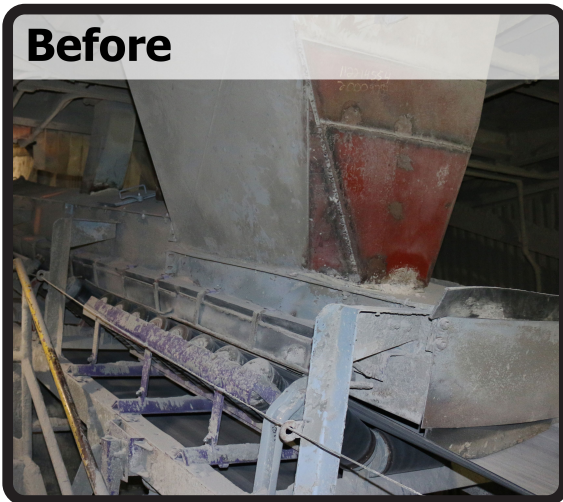
Before

Previous system resulted in costly fines, excessive maintenance, loss of production and structural weigh load concerns due to spillage.

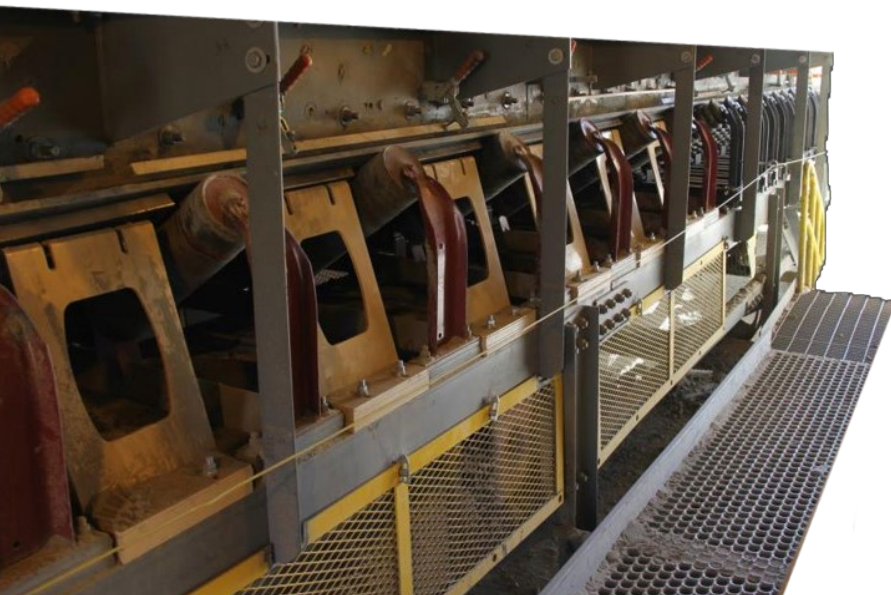
(Left) The adjustable **BeltStabilizer Bracket & Bars** are installed between the **Troughing Idlers**. Note the **BeltSeal Clamps** with **DoubleLip DustSeal** skirting.
