## **Inflatable Liners Last 11 Years with Zero Downtime**

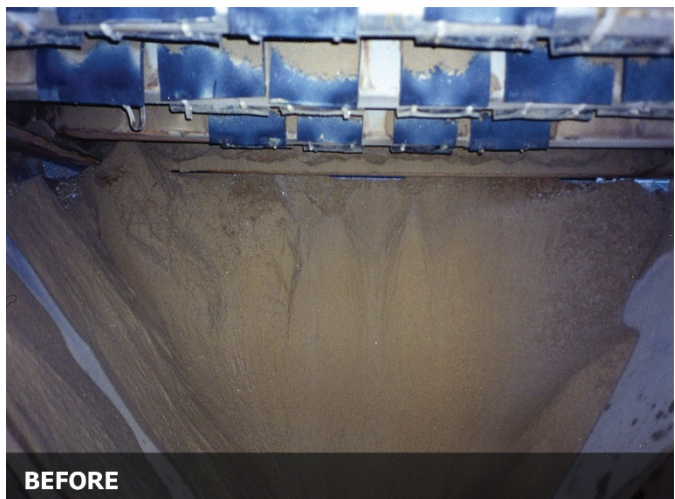
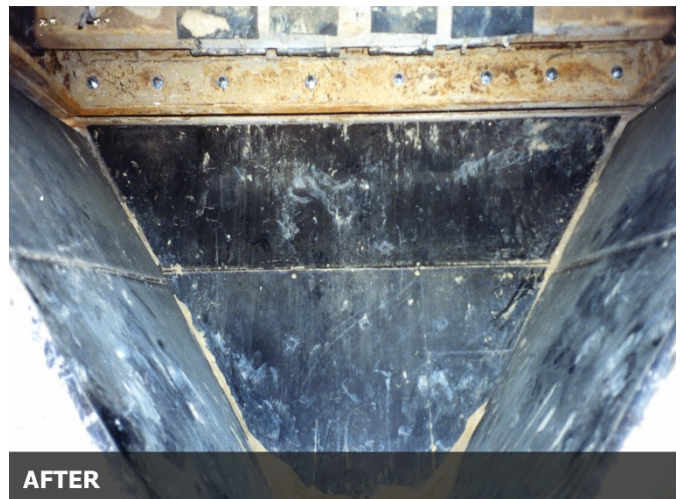
A Sand and Gravel operation in Phoenix, Arizona had experienced chute buildup, along with plugging due to heavy clay content in the material. Safety issues were cited because the chute had to be manually cleaned by plant operators on every shift. Confined spaces and a lack of space to maneuver added complexity to the situation. These problems required downtime during production hours which impeded plant availability.

**(Before) An example of a chute backed up by sticky material buildup. After Valley Rubber's liners were installed the chute was clear and functional.**

Valley Rubber designed a custom manufactured Inflatable Liner package to fit the application. The rubber compounds involved played a major role in the cost-effective performance of the liners and offered protection against impact, cuts, tears and abrasion. This system dramatically reduced the buildup of sticky material.

The Inflatable Liner system came with a control box that supplied minimal plant air to the liners. These control boxes can be modified to have the following features: additional air outlets, lighting, heating, outside controls, operating indicators, remote controls and more.
