Rubber-Lined Haul Trucks Have Zero Box Maintenance After 5 Years!

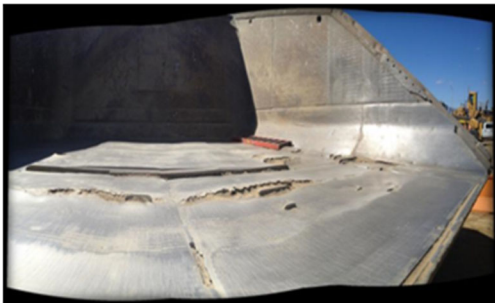
A fleet of Haul Trucks owned by a Peruvian mine operation had high maintenance due to steel lining fractures, which in turn decreased the availability of their equipment. The truck beds had a lower life expectancy due to the issues caused by the steel, and site personnel experienced poor working conditions.

Common fractures and liner damage in truck boxes with steel liners.

Starting in 2012, Valley Rubber began to install 6" thick rubber liners in Komatsu 830 and 930 Haul Trucks with the intention of extending the useful life of the truck box to five years without performing maintenance or repairs, except the monthly routine inspections and the rotation of the central pieces of the lining every three years. The addition of the rubber liners did not affect the load factor.

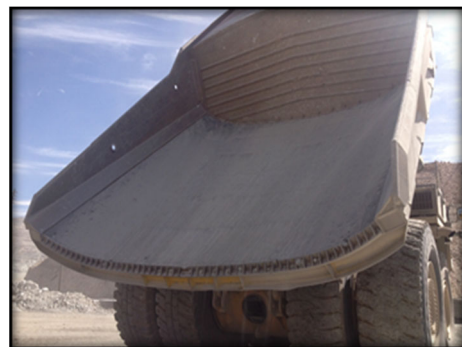
Komatsu 930 Haul Truck, five years of using rubber liners and still in service.

Because rubber has the ability to absorb 400% more impact force than steel, the whip effect on the operator's body was considerably reduced, as well as the noise inside of the main cabin. More productive work hours resulted from these positive benefits.

It is evident that rubber-lined trucks in this operation had superior performance when compared to steel-lined trucks. The trucks that were first lined in 2012 have hauled as many as 10,898,400 tons...all with zero box maintenance!
