Inside any processing circuit, a Transfer Point is a system where mineral flows from one point to another. It is common to see **wear, impact,** and **general abrasion** of the structural housing. Valley Rubber focuses on the supply of products used to line these structures. Depending on the type of mineral and movement that is occurring, Valley Rubber will recommend various liner types and designs that provide the wear and performance improvement the customer needs while delivering the lowest cost of operation.

Valley Rubber's System

Solids Transfer Systems

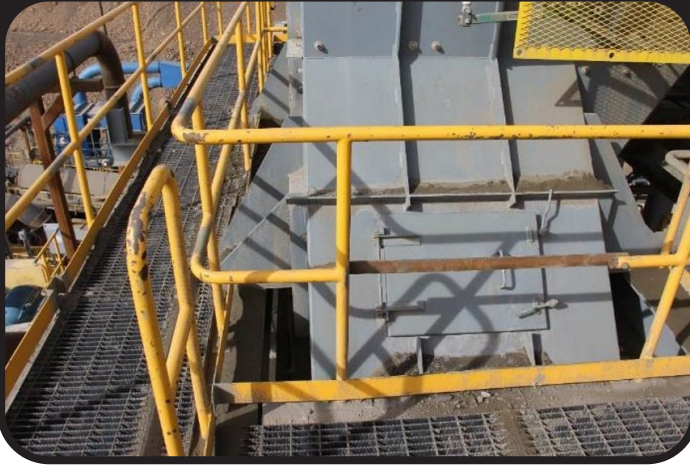
Unsafe access point to the chute

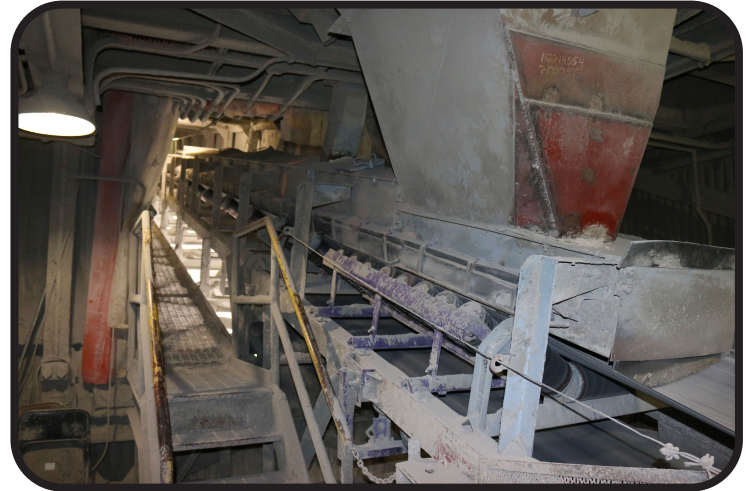
Spillage was a costly issue with this old system.

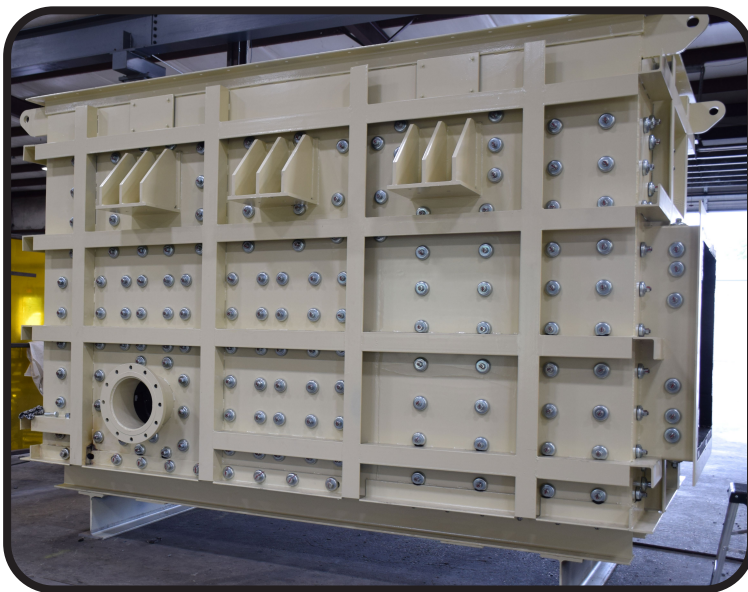
In-house fabricated ST Box

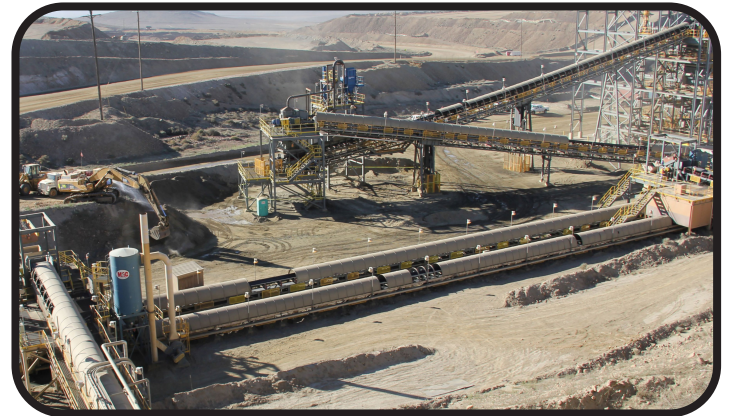
Transfer Chute between Conveyors

The Valley Rubber team laser scanned, designed, manufactured, and provided installation support for a replacement chute system. The final system included an automated inflatable rubber lining, control panel, and new chute fabrication to support the system.

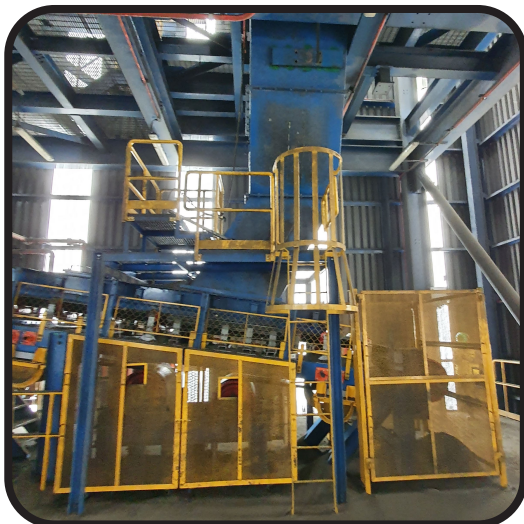
Before Valley Rubber's system was installed

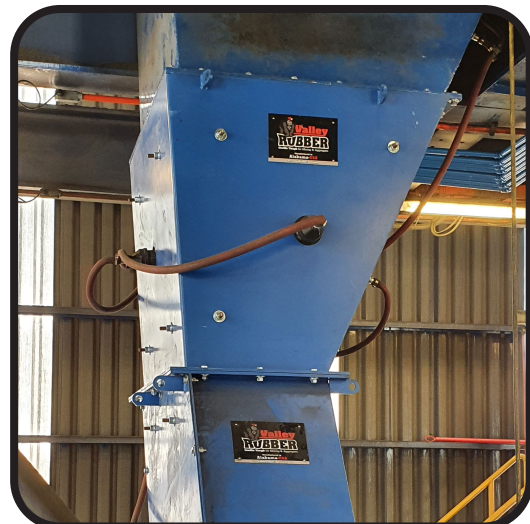
Valley Rubber's new system

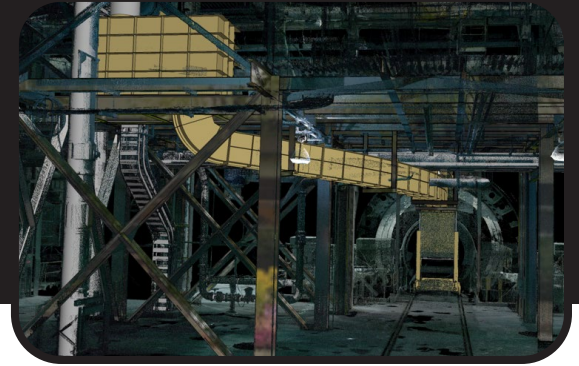
Pre-engineering detail of the Launder System

For a Latin American operation, the Valley Rubber team designed, engineered, manufactured, and installed a system that includes a vertical chute, an ST Box reception chute, and a launder system containing magnetic rubber with a ceramic inserts liner system that will outperform the life of the original system by at least 8 times.

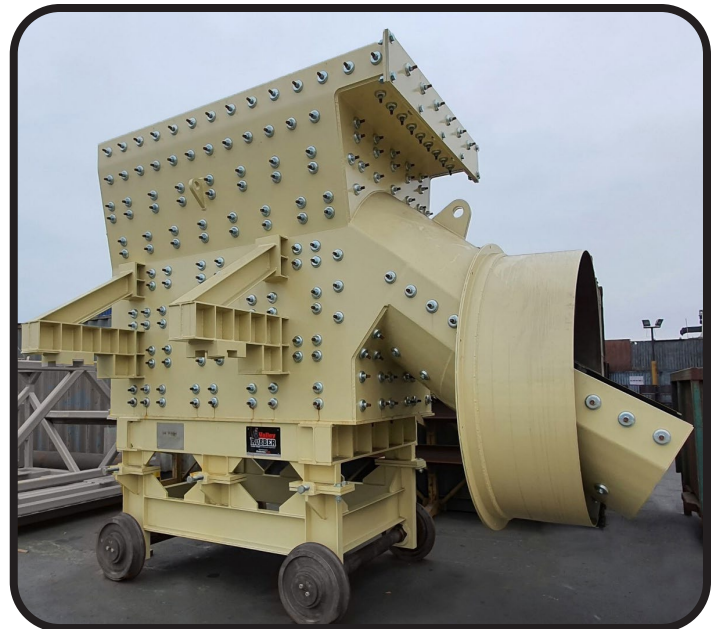
Mill Feed Carts

An operation may experience the following: frequent liner maintenance, plugging and safety issues with their current Mill Feed Carts. At Valley Rubber, we custom design and manufacture both the Mill Feed Cart and Rubber-Ceramic Wear Liners to solve your particular issues.

- Rapid liner changes are possible due to our bolt-in reduced weight Rubber-Ceramic Liners
- Employees can perform safer and easier maintenance with convenient access inside the chute
- Bolt-in components eliminate welding
